FATIGUE AND CORROSION PHENOMENON ON FAILURE OF WATER WALL TUBE BOILER

Eka Febriyanti^a, Amin Suhadi^a, Laili Novita Sari^a

^aBalai Besar Teknologi Kekuatan Struktur (B2TKS), Badan Pengkajian dan Penerapan Teknologi (BPPT), PUSPIPTEK, Serpong, 16314, Indonesia

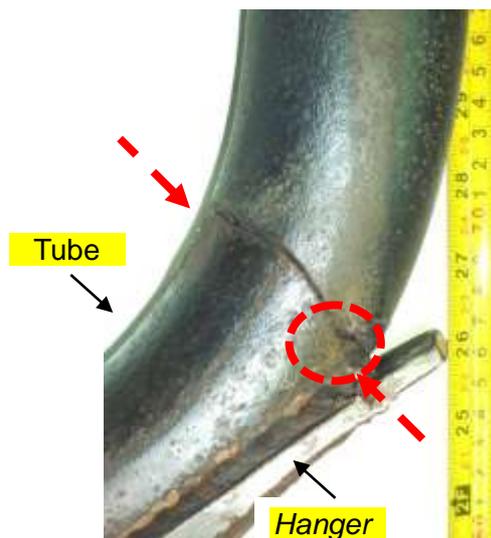
Visual and fractography examination result show that water wall tube of a boiler investigated is broken perpendicular to tube axis and the fracture location is around weld area (Figure 5). Moreover, it is also found a sharp failure tip on surface fracture of the tube at welded area (dotted circle on Figure 6), and this area is identified as initial fracture. Further observation on fracture surface on other area also found the track of crack propagation caused by dynamic loading, which is normally called fatigue fracture (Figure 7). This evidence is unique, consists of smooth and rough area and only appear caused by fatigue fracture. There is no any other kind of fracture can produce this evidence ³⁾. Smooth area represents crack propagations during dynamic load, usually marked with row of curve line that is named “beach mark” ⁴⁾. On this specimen, beach marks are identified as about 35 mm length from the point of initial propagation (Figure 7-9). Rough surface indicates residual fracture, where sudden brake occurs because the remaining cross section is no longer able to support the applied load. Residual fracture surface usually has contours angle of about 45° to the tube axis (Figure 10) ⁴⁾.

Figure 5.
Position of failure on wall tube boiler

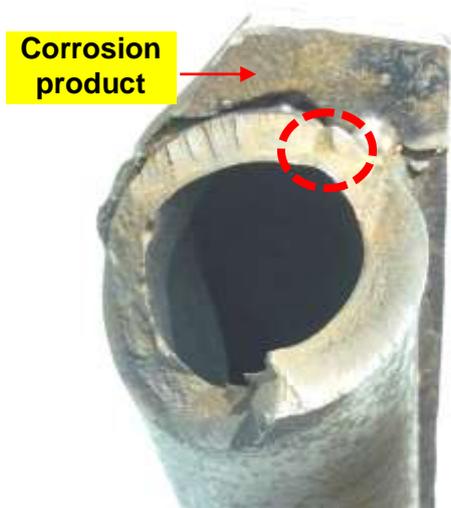
Figure 6.
Sharp failure tip on weld area of surface fracture of tube boiler investigated

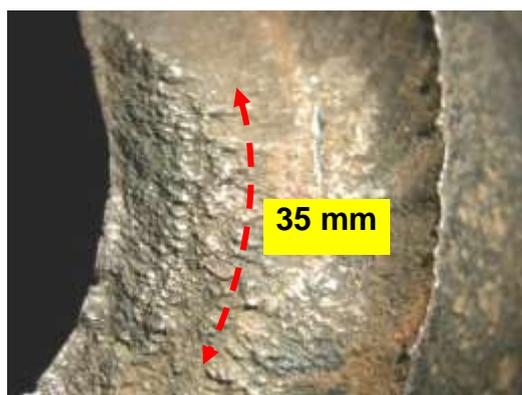
Figure 9.
Higher magnification on crack propagation area (B on figure 7) shows beach marks

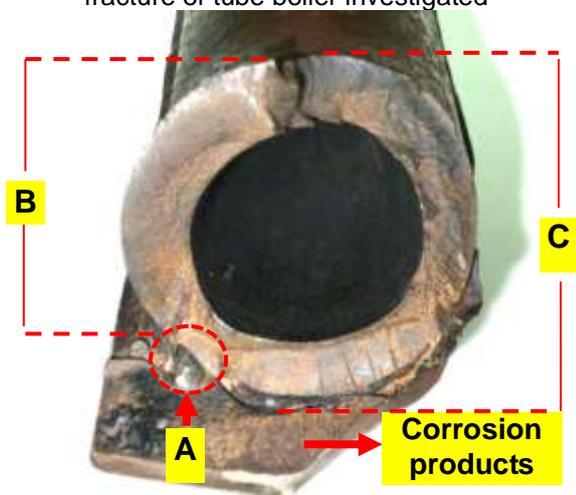
Figure 7.
Surface fracture of wall tube boiler shows evidence of fatigue fracture, consist of (A) initial crack area, (B) crack propagation area, and (C) residual fracture area

From fractography and metallography result show that the type of fracture is fatigue fracture which is indicated by the presence of beach mark on the fracture surface (Figure 7-9)³⁾. Moreover, it is also found corrosion product on the fracture surface (Figure 6-8), so that it can be confirmed that the main cause of failure is a combination of fatigue fracture and corrosion attack. Fatigue crack can be generated when dynamic load is operated during operation. In this tube boiler, dynamic load can occur when the tube is vibrated due to improper tightening by the hanger. Especially when fluid flows through the bended tube, the change of flow direction gives significant energy to vibrate. This vibration last very long time, so that with the presence of manufacturing defect (Figure 22-24) which acted as stress raiser or welding that also produces residual stress, crack will start to form and then propagated until the tube broken. As the crack started to form, corrosive agent may infiltrate into the tube material and reacts with base metal to produce rust ^{7,8)}. As a result, crack propagation running faster and faster until the remaining tube strength is no longer

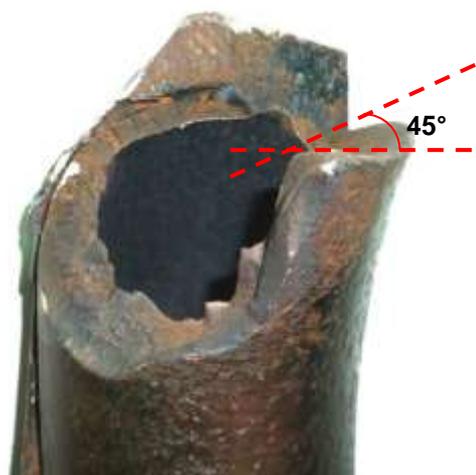
Figure 10.
Higher magnification on residual fracture area (C-on figure 7) shows fracture contour that has 45° angel to tube axis.

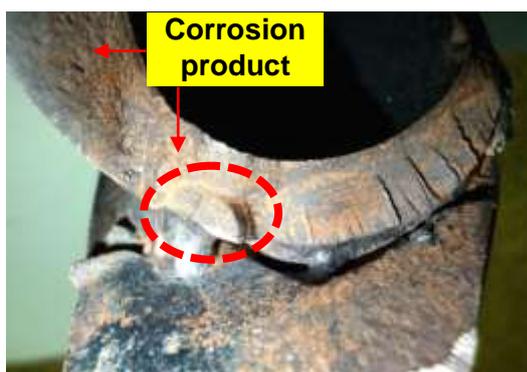
Figure 8.
Higher magnification on initial crack area (A area on Figure 7).

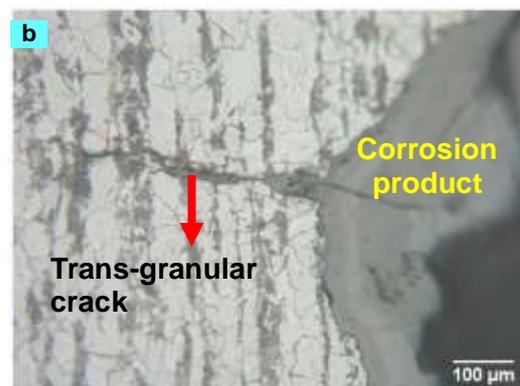
Figure 15.

Microstructure of base metal both on fracture area (location-a) and away from fracture area (location-b) is a mixture of ferrite and pearlite (Figure 14 and 15). This is a normal microstructure of carbon steel material. Metallographic examinations result also shows that trans-granular cracks are exist in both areas. Those cracks produce corrosion agent entering into the structure and then corrosion reaction may occur.

Microstructure of base metal (specimen1 location-b) consist of ferrite-pearlite mixture. Trans-granular crack is observed as filled by corrosion product. Etched by: 2%Nital

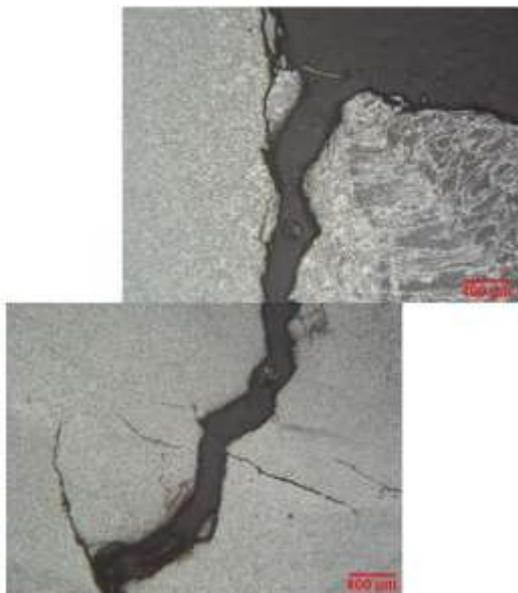
Specimen number 2 is taken on weld area between tube and hanger (Figure 16). Microstructure of this area is bainite and a macro crack is observed, propagated from weld area to base metal (Figure 17).

Figure 17.
Macro crack is found on weld area and propagated into base metal. Etched by: 2%Nital

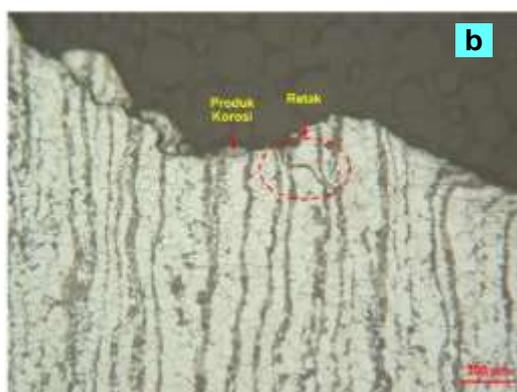
Specimen number 3 is taken away from surface fracture (Figure 18). Microstructure of this area is a mixture of ferrite and pearlite (Figures 19-20). Metallographic examination on this area also found micro crack on base metal (Figure 20).

Figure 20.
Microstructure of base metal in other area consist of a mixture of ferrite and pearlite. Micro crack is also found in this area. Etched by 2%Nital

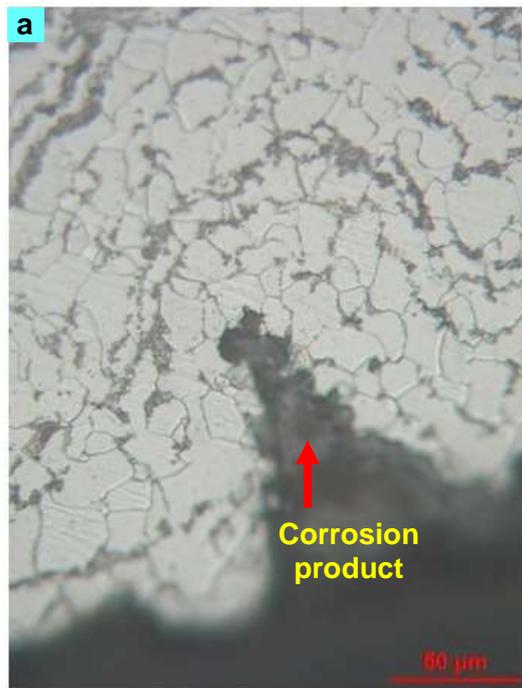
Specimen number 4 is taken from cross section of un-installed water wall tube which is still on good condition (Figure 21). Microstructure of this specimen is a mixture of ferrite and pearlite like microstructure of other specimens. However, this specimen shows a small manufacturing defect in the structure (Figure 22-23). The defects are formed like a small hole and the microstructure grain boundary is following this contour⁵⁾. This small hole is also filled with corrosion products (Figure 22-23).

Figure 22.
Microstructure of un-installed tube consist of ferrite and pearlite. Small manufacturing defect is found and filled by corrosion product. Etched by 2%Nital

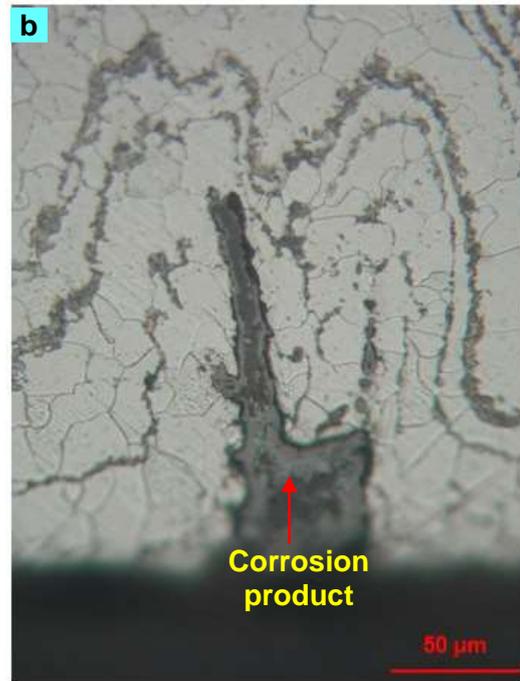
Figure 23.
Defect on other area (b), grain boundary of structure is following the contour of manufacturing defect. Etched by 2%Nital

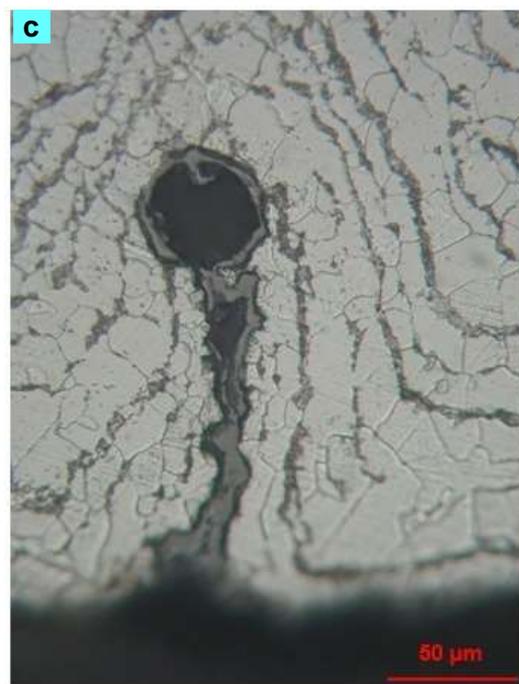
Figure 24.
Defect on other area (c), grain boundary of structure is following the contour of manufacturing defect. Etched by 2%Nital
