FAILURE ANALYSIS ON SLINGER DISK PIPE OF PURIFIED TEREPHTALIC ACID (PTA) VESSEL

Sukandar¹, Triwibowo¹, Yana Heryana¹

¹National Laboratory for Structural Strength Technology
Agency for the Assessment and Application of Technology
e-mail: sukandar@bppt.go.id

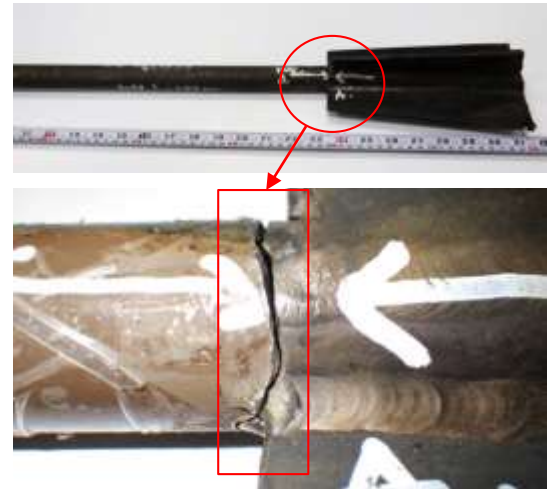
Failure took place on the both pipes of the slinger disk pipe at the strengthening

plates tip. For this failure analysis, it is taken one failure pipe as sample (Figure 2 and 3).

Figure 3. Location of Fracture on The Slinger Disk Pipe (Red Circle And Magnified In Red Square)

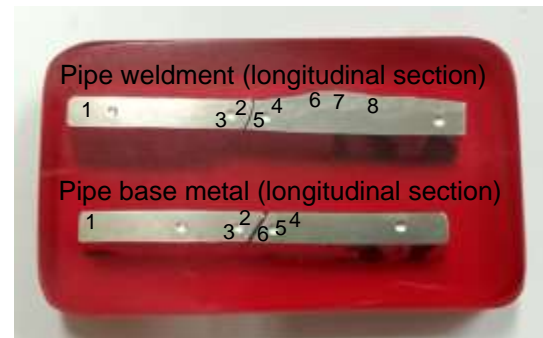
Location of Hardness Tests on The Sample of Slinger Disk Pipe

Hardness test result as represented by a sample of slinger disk pipe shows that the material hardness is in accordance with the standard of lean duplex 2205 as shown in Table 4.

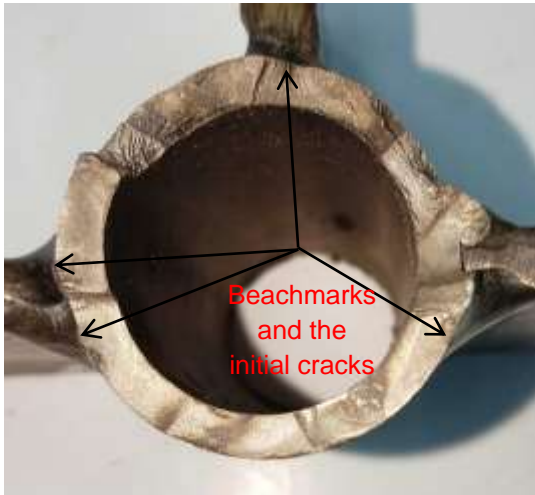
Examination result of fractography on the fracture surface of slinger disk pipe shows multiple beachmarks and their initial cracks as an evidence of fatigue fracture under reverse bending load as shown in Figure 5-6.

Initial crack of each beachmarks are located at the center of beachmark.

Multiple Beachmarks on The Fracture Surface And Their Initial Cracks Location

As can be seen in the Figure 5 that the beachmarks position are diametrically opposite each other in the same transverse plane, it indicates that the applied bending moment is reversing (alternating), all point in pipe are subjected alternately to tension and compression stress²⁾. It means that the rotation of slinger disk pipe is reversing (alternating).

Moreover, it can be observed that the area of beachmarks are relatively reach more than half of cross section area of the

pipe (Figure 5). It indicated that the nominal load on the slinger disk pipe is low.

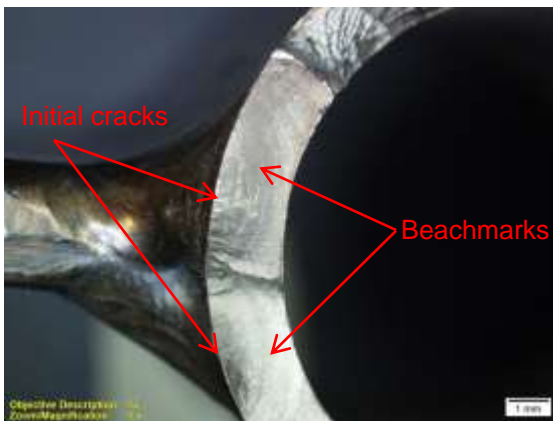
Magnification of Figure 5 Shows Two Beachmarks With The Cracks Initiated From Two Weld Joints

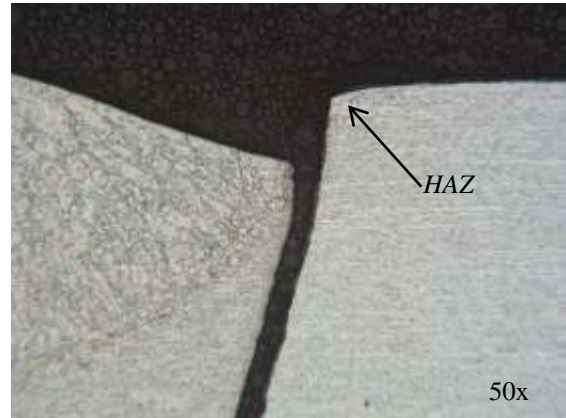
Examination result of metallography shows that the crack propagation initiated from HAZ which then propagated to base metal, while the microstructure is austenite in ferrite matrix³⁾ in normal condition⁴⁾, as shown in Figure 7.

The Fracture is Initiated From HAZ Which Then Propagated to Base Metal.

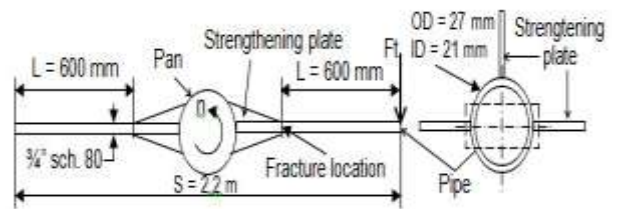
Figure 7. Dimension of Slinger Disk Pipe

Bending stress at the plate tip $\sigma_B = Mr/I = 2,605,675 \times 13.5 / 16,532 = 2,128 \text{ N/mm}^2$

Calculation result is maximum stress σ_B is higher than the tensile strength of material.

- With the motor power is 30 kW and the rotation is 60 rpm, the maximum bending stress on the location of fracture is above tensile strength of lean duplex 2205
- With the motor power is 30 kW and the rotation is 60 rpm, need pipe dimension of 1½" sch. 40
- With the pipe dimension of ¾" schedule 80, the power should be limited up to 4.54 kW
