## **ANALYSIS OF DENICKELIFICATION PHENOMENON ON HEAT EXCHANGER TUBE**

**Amin Suhadi, Eka Febriyanti, Laili Novita Sari**

Balai Besar Teknologi Kekuatan Struktur (B2TKS) – BPPT  
Kawasan Puspitek Serpong Tangerang 15314  
e-mail : amin.suhadi@bppt.go.id, eka.febriyanti@bppt.go.id, laili.novita@bppt.go.id

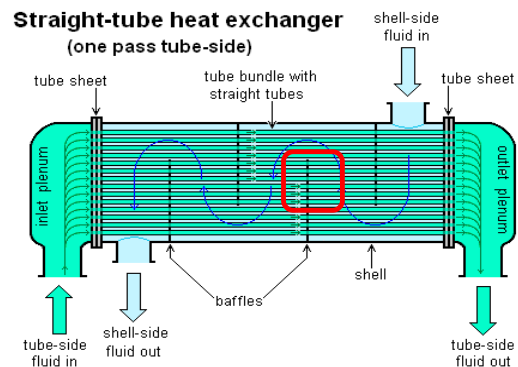
Figure 1.

The position of the leakage tube on HE<sup>[1]</sup>. Detail parameters are listed in Table 1.

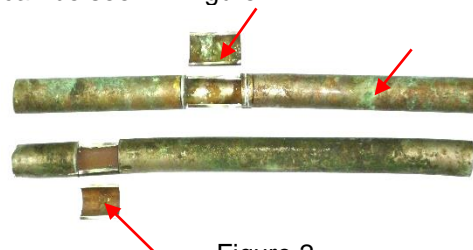
Figure 2.

Photograph of leakage straight Exchanger Tubes and location of of cutting for samples of further examinations. Red arrows indicate the presence of deposits on the inner and outer surfaces.

Two small pieces are cut as samples for further examination such as fractography, metallography and Scanning Electron Microscopy examinations. Locations of cutting are exactly on the area of leakage. It can be seen from this photo that some deposits are found either on the inner surface or on the outer surface.

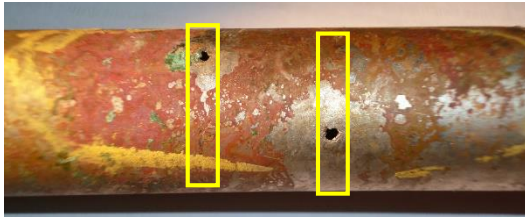
Figure 5.

The result of visual and macro fractography examination on the specimens show that some pittings and holes are found on each tube investigated. All holes are initiated from inside surface to outer surface (Figure 5 to Figure 9). This result also shows the evidence of deposit that sticks to either the inner or outer surface of the tubes. The colour of deposit which presence around the pits or holes is green (Figure 5 to 9).

Holes and deposit on straight heat exchanger tube and location of specimens taken for further examinations and testings.

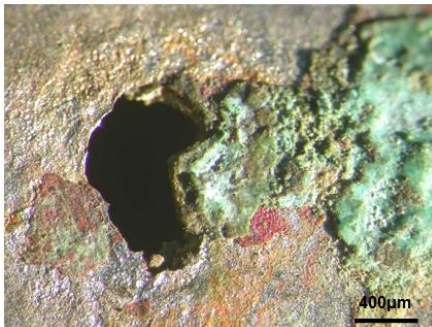
Figure 6.

Higher exposure on location 1, show the presence of green deposit on the outer surface around the hole.

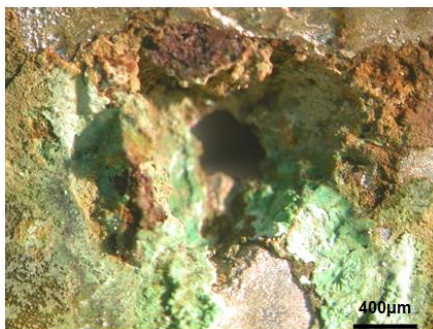
Figure 7.

Higher exposure on location 1 from the inner surface, shows green deposit around the hole.

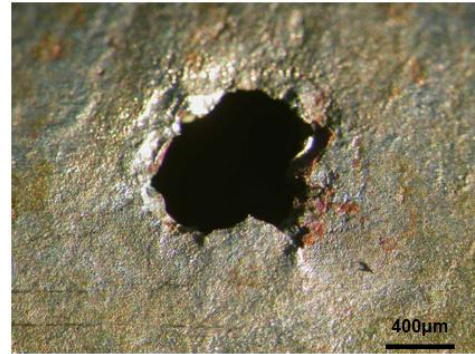
Figure 8.

Higher exposure at location 2 on the outer surface, shows the hole with little deposit.

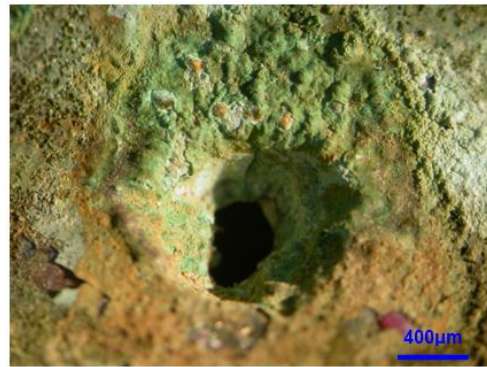
Figure 9.

Higher exposure on location 2 from the inner surface, shows green deposit around the hole.

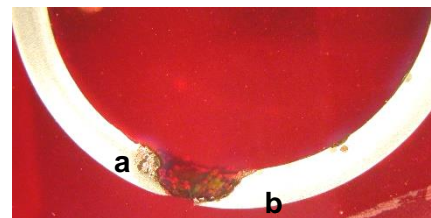
Figure 10.

Cross section of the sample for metallographic analysis on location 1. (a) and (b) are points for examinations

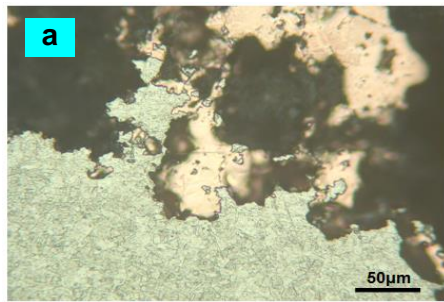
Figure 11.  
Metallography result on area (a) shows Cu deposit that stuck on the microstructure.  
Etched by:  $K_2Cr_2O_7$

The purpose of metallographic analysis on location 1 and 2 is to confirm the result of observation on macro fractography concern with the presence of pitting, hole and deposit. The result of metallographic examination also confirms that all of the pitting, hole and deposits are existing. The deposit with green and brown colour is identified as residual Copper which is a result of the denickelification process of tube material Cu-30Ni.

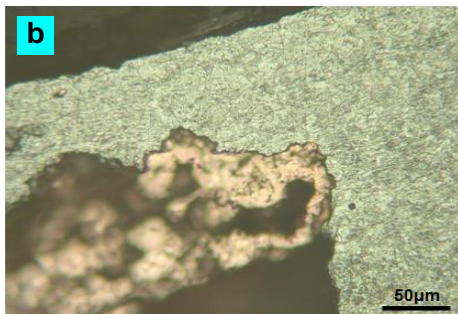
Figure 12.  
Metallography result on area (b) shows the Cu deposit that stuck on the microstructure.

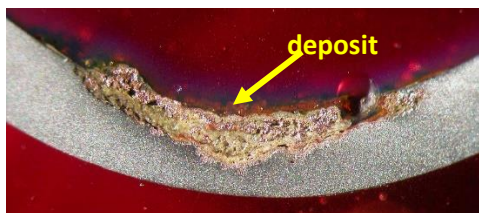
Figure 13.  
Deposit is clearly seen on the inner surface of a cross section of the sample on location 2. This sample is taken for metallographic analysis.

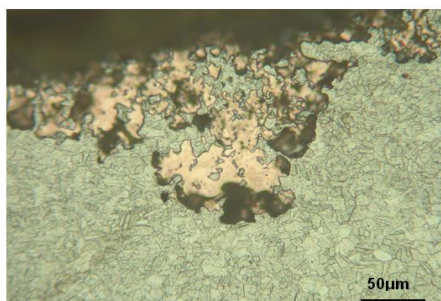
Figure 14.  
The metallographic result on the cross section of the sample on location 2 shows Cu deposit on microstructure, as result of denickelification.  
Etched by:  $K_2Cr_2O_7$

Denickelification phenomenon that occurs in this tube is caused by the formation of scale on the inner surface of the tube that inhibits the formation of the passive oxide layer of the alloy. This condition is also promoting the local hot spot in a certain area. As a result, thermogalvanic reaction occurs and generates selective leaching corrosion to expel Nickel element out and redeposit

Copper into the surrounding area. Several things can be done to prevent denickelification phenomenon, one of them is to avoid the formation of scale by conducting routine mechanical cleaning for heat exchanger tube and to control the speed of sea water flow above 1,524 m/s so that formation of scale can be hindered<sup>[6]</sup>. This phenomenon could occur for the alloy at an operational temperature higher than 149°C<sup>[5-8]</sup>.

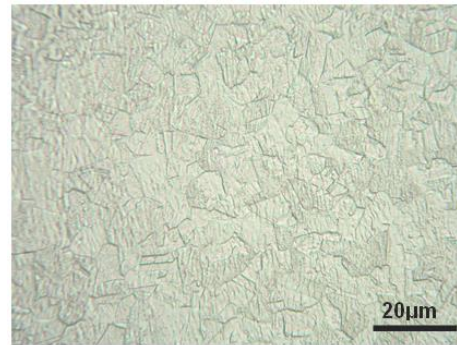
Figure 15.  
The microstructure of a normal tube is  $\alpha$ -phase with austenitic structure. No inclusions or deposits are found. This sample is taken 10 cm from the hole and etched by  $K_2Cr_2O_7$

Examination result of the normal tube that taken from a location away from the hole has no deposit, no crack and no inclusions. The microstructure is typical of Cupro Nickel structure such as  $\alpha$ -FCC (austenitic) with twin crystal of Cu-Ni (Figure 3).

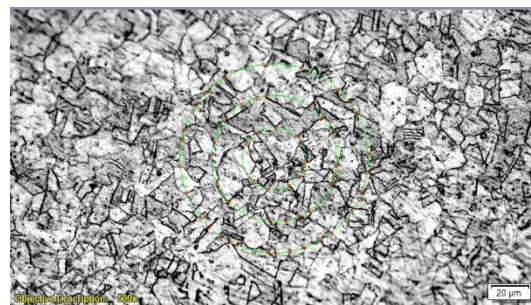
Figure 16.  
Grain size measurement result of the tube by Intercept Heyn method shows that average grain diameter is 12,17  $\mu m$ .

The result of grain size measurements refers to ASTM E-112-13<sup>[7]</sup> standard (Figure 16) show that the tube investigated has average grainsize of 12,17  $\mu m$ . While measurement on Copper deposit grain diameter has a value much higher than normal grain size (37  $\mu m$ ).

Although exposure of this material to a high temperature for a long time could promote grain growth the increasing of grain size has never been such high (12,17  $\mu\text{m}$  grows to 37  $\mu\text{m}$ ). The only possibility to obtain the grain size much higher than normal grain is by melting and then followed by solidification mechanism. This evidence confirms that the red colour which is existed on microstructure is not grain growth of Copper base metal but Copper deposit which is coming from the denickelification process and then redeposits to the tube surface.

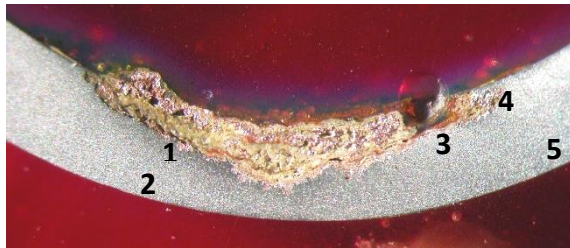
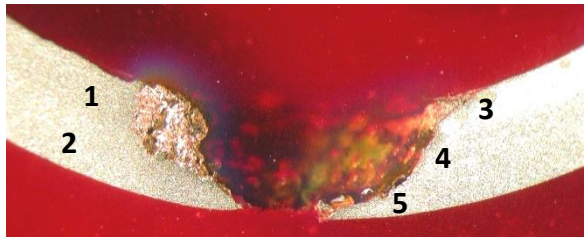
Figure 17.

Points of indentations for hardness test of cross section tube around the hole. Refer to Figure 5, (a) location 1, (b) and (c) location 2

Hardness testing result indicated that the tube investigated has average hardness value in accordance with ASTM B-466 standard for 70Cu-30Ni (Copper-Nickel alloy)<sup>[4]</sup>.

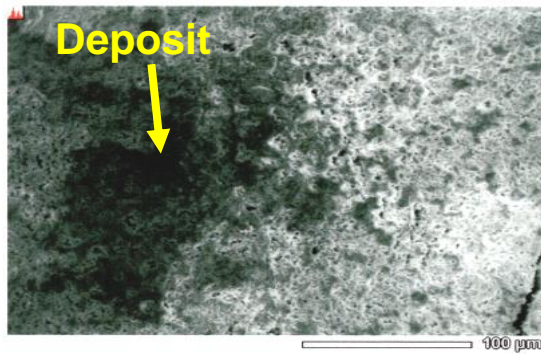
The result of SEM examinations on the surface of the hole of leakage tube shows that this area is covered by deposit (Figure 18). Further examination on this deposit using Electro dispersive spectrometer (EDS) which is shooting on a small spot of deposit (Figure 19) indicated the presence of Cu (31,81%) and Ni (6,99%). Moreover, this analysis also confirm the existence of agressiv / corrosive ion such as  $\text{S}^{2-}$  (0,09%) and  $\text{Cl}^-$  (10,22%) (Table 4).

Figure 18.  
SEM photograph of hole surface which indicated that this area is covered by deposit

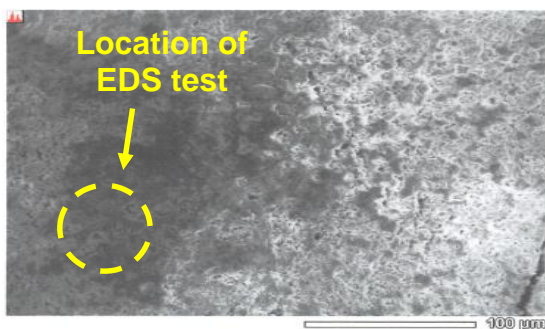
Figure 19.  
Location of a spot for examination by EDS
