IMPLEMENTATION OF ROOT CAUSE ANALYSIS METHOD TO INVESTIGATE FAILURE OF FRONT WALL TUBE BOILER

Eka Febriyanti¹, Amin Suhadi¹, Laili Novita Sari¹

¹National Laboratory for Structural Strength Technology
Agency for the Assessment and Application of Technology
e-mail: eka.febriyanti@bppt.go.id

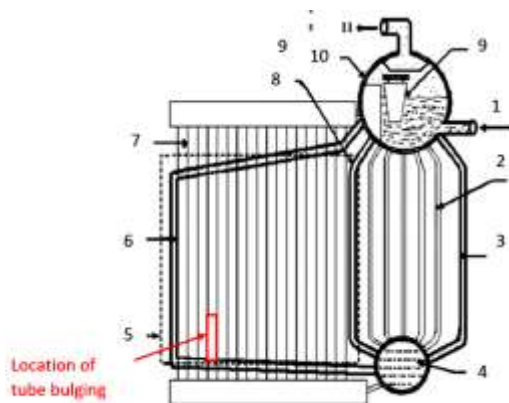
Figure 1.

Position of front wall tube which failed (red square with red arrow).

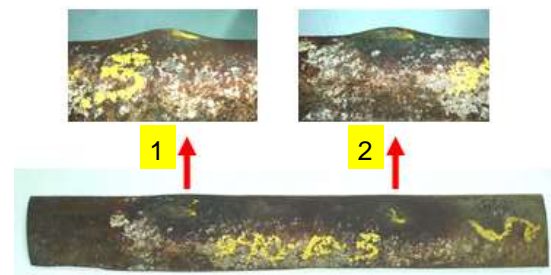
Visual and macrographic examination result shows that front wall tube investigated has two bulges side by side in close distance (Figure 2).

Figure 2.
Bulging on locations 1 and 2 of fail tube investigated.

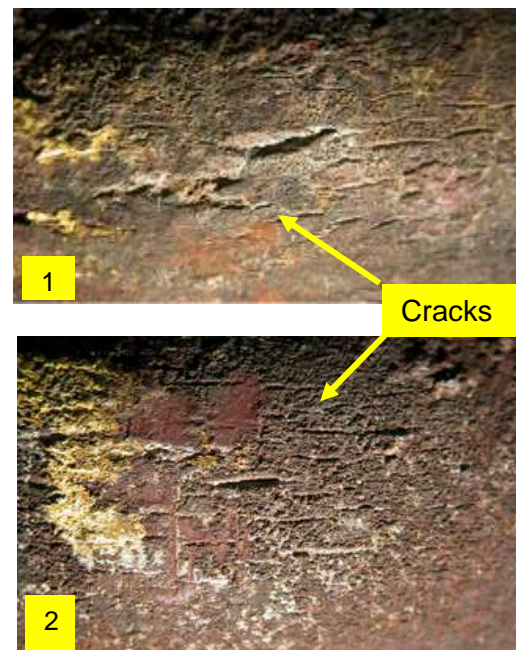
Figure 3
Longitudinal cracks on bulges outer surface on location bulge 1 and 2.

Further macro fractography examination on the bulge area, it is found that there are many longitudinal cracks on the outer surface of the bulges (Figure 3). All of the cracks are close to each other and have a parallel direction with the tube axis. This kind of crack is typical of cracks that are formed in brittle

material⁸). In fact, the tube material is low carbon steel, which is not brittle material. Therefore it can be concluded that the base material on the bulge area has already been oxidized to become steel oxide, which usually brittle⁹. Some of the big cracks are propagated and penetrated into the inner tube until the tube leak (Figure 4). Deeper examination on the inner surface of the bulges, it is found that there are thick black and white scale exist and covered the whole area of the bulge (Figure 5). This scale can reduce heat transfer from outside to the media inside the tube¹⁰.

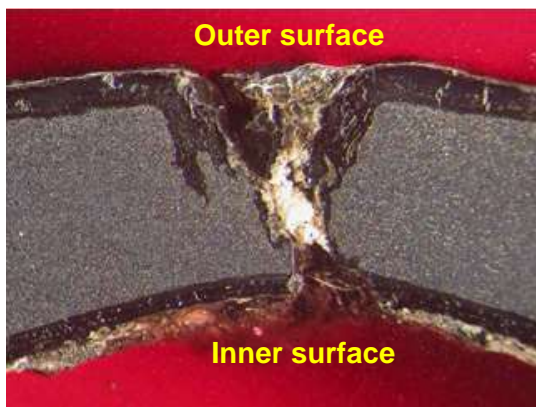
Figure 4.
Crack from the outer surface that penetrates to inner surface on bulge area.

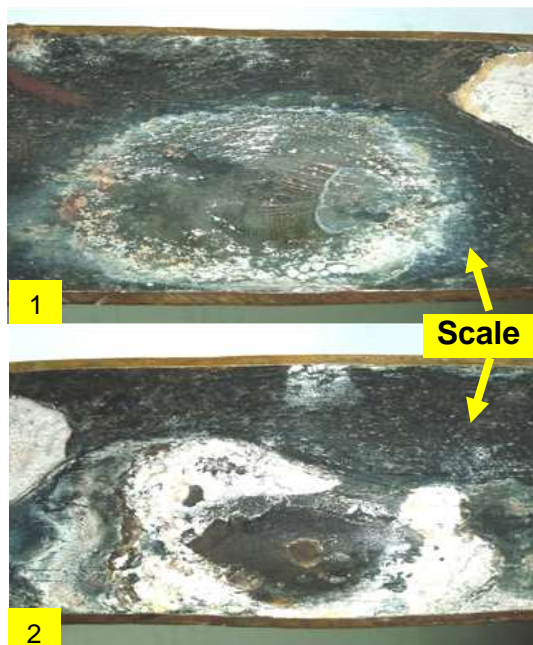
Figure 5.
Black and white scale that formed on the inner surface of bulges on location bulge 1 and 2.

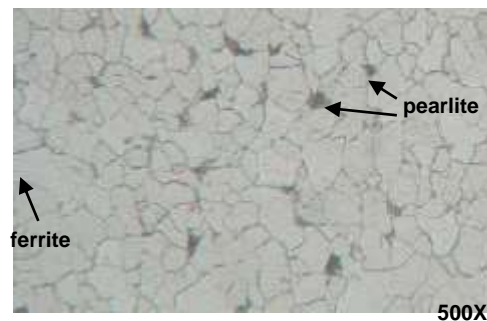
Figure 6.
The microstructure of the specimen is located away from the bulge, which consists of a mixture of ferrite (bright) and pearlite (dark). Etched by: 2% Nital.

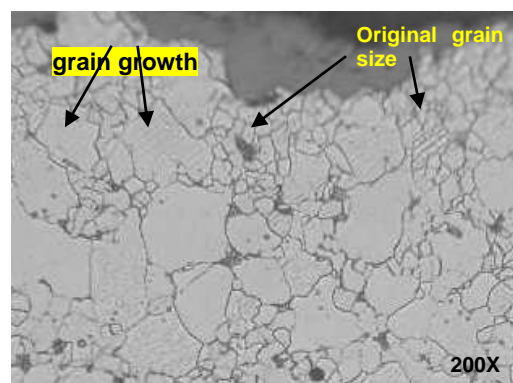
Figure 7.
The microstructure of the specimen located on the bulge. Some grains are grown. Etched by: 2% Nital.

The change of microstructure is evidence that there was local overheating occur in this area¹¹). Moreover, the change of microstructure can also have a significant effect on the mechanical properties of the tube. Tensile strength and hardness value will be

decreased with the presence of bigger grain size as well as spheroidized pearlite¹².

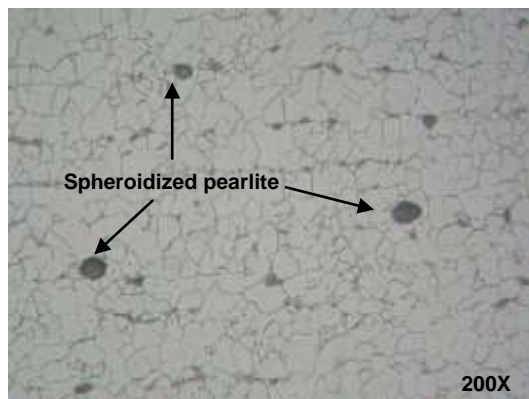
Figure 8.

The microstructure of the specimen located on the bulge area indicated that some lamellar pearlites are transformed into spheroidized pearlites. Etched by: 2% Nital.

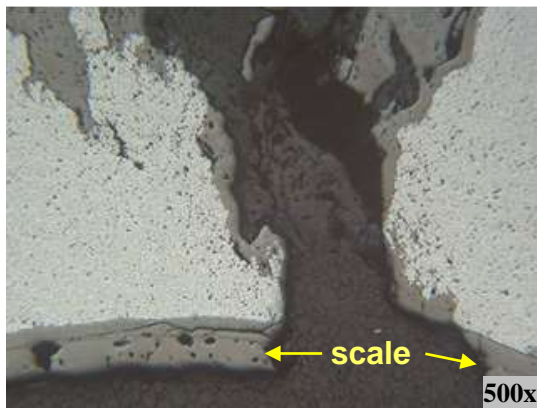
Figure 9.

Another result that can be obtained from metallographic examination of the cross-section in the bulge area is the presence of scale on the inner surface (Figure 9). This scale can be formed due to the attachment of some particles that occur during long term operation¹³. The scale that has lower heat conductivity than steel has a significant effect of heating transfer from the outside tube into the condensate that flows in the inner tube¹⁴.

The microstructure of the specimen on the cross-section of the bulge area shows a scale attached to the inner surface of the tube. Etched by: 2% Nital.

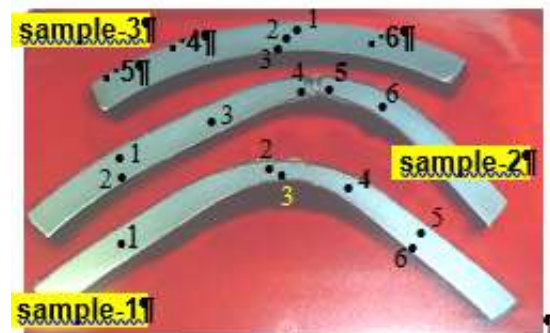
Figure 10.

Samples for the hardness test. Samples 1 and 2 around the bulge area while sampling 3 away from the bulge. The numbers are representing the point of indentations.

From this table, it can be seen that in general, the hardness properties of this tube are decreased from the original specification

for SA 192 material, and the highest decreased is achieved around the bulge. This phenomenon confirms that local overheating has occurred in the bulge area. Because tensile strength is proportional to hardness, therefore tensile strength of this area is also decreased^{2,4)}.

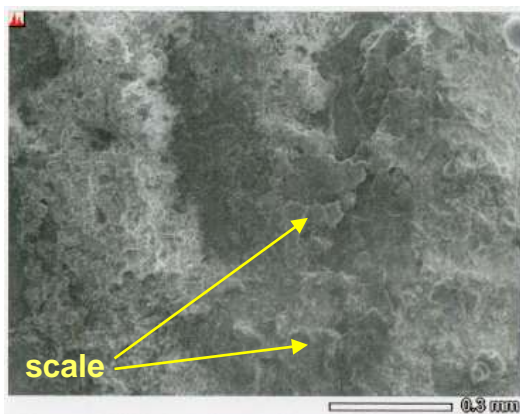
Figure 11.

Photograph of scanning electron microscopy examination result on leakage surface.

From Figure 11, it can be seen that the leakage surface is covered by scale and rust; there is no evidence of fatigue or creep fracture or other mechanical damage can be found.

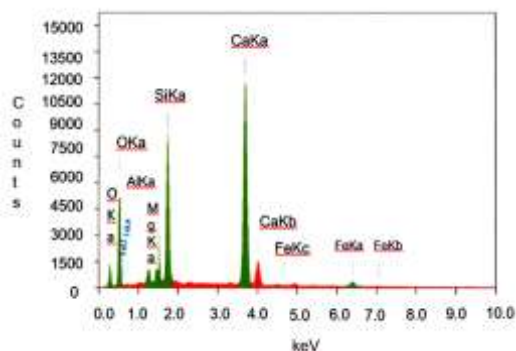
Figure 12.

EDX spectrum on leakage surface shows the elements' content in this area.

Figure 12 and Table 4 show that the dominant elements in this area are O, C, Si, and Ca. All of those elements represent the scale that formed around the leakage.

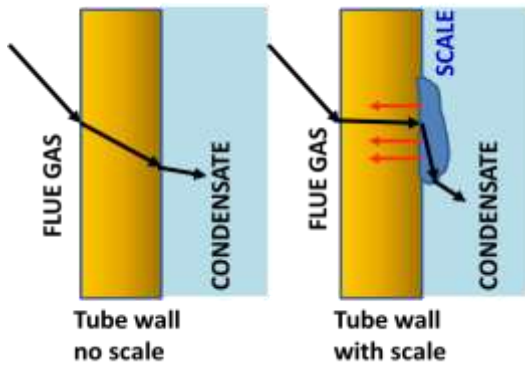
As a result, the heat is retaining at the tube wall where the scale is attached, and consequently, this area has a higher temperature than other areas. Illustration of this phenomenon can be seen schematically in Figure 13. As local long-term overheating is taken place, microstructure degradations occur then its mechanical properties are also decreased. Therefore, this area is easy to be deformed by existing operational pressure, so that bulging followed by cracking occur. As the crack started to open, the corrosive agent may infiltrate into the tube material and reacts with the base metal to produce rust¹⁷⁾. As a result, crack propagation running faster and faster until leakage occurs.
