## OXIDE LAYER CHARACTERIZATION OF AlMg<sub>2</sub> CLADDING OF IRRADIATED U<sub>3</sub>Si<sub>2</sub>/Al FUEL WITH 4.8 gU/cm<sup>3</sup> DENSITY

Juan Carlos Sihotang<sup>1</sup>, Maman Kartaman Ajiriyanto<sup>1</sup>,  
Ely Nurlaily<sup>2</sup>, Junaedi<sup>2</sup>, Aslina Br. Ginting<sup>1</sup>

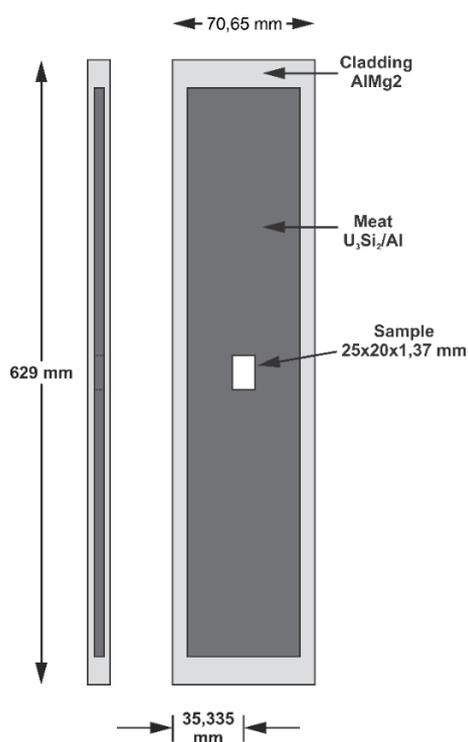
Figure 1. Sampling position in CBBJ251 fuel plate using punching-device. The dimension of the fuel plate was based on non-destructive test result [24].

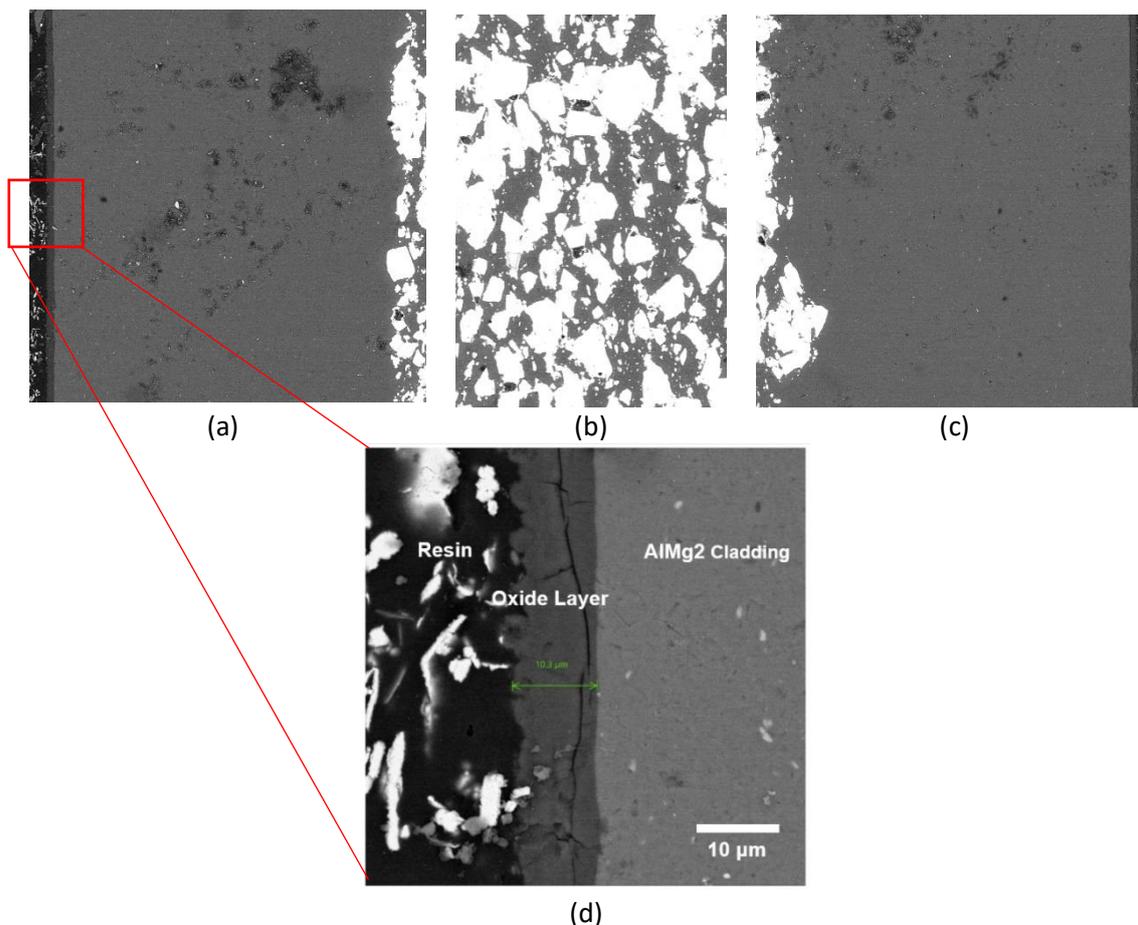
The low magnifications ceramography observations of the fuel cross-section shows the oxide layer on both outer cladding surfaces of the AlMg<sub>2</sub> cladding as shown in Figure 2(a)-(c). The detailed image of the oxide layer is shown in Figure 2(d). The formed oxide layer looks dense, non-porous, and no granular aspect appearance so that pitting corrosion is unlikely to occur, in contrast to the pitting corrosion observations by Leenaers [22] as shown in Figure 3. In Figure 2(d), the cracks are clearly visible along the oxide layer. Similar cracks on the oxide layer were also observed in the other studies [23], [26] as depicted in Figure 4. Leenaers et al [23], observed that the cracked oxide layer did not firmly attach to the irradiated AlFeNi cladding and can be removed easily. The crack pattern, as depicted in Figure 4(c), were suggested to be caused by dehydration (evaporation of the lattice water) of the oxide layer during the drying of the fuel element in the hot cell. Wintergest et al [26], who studied the corrosion product of unirradiated AlFeNi alloy obtained from autoclaves, also observed similar cracks on the oxide layer, stating that the cracks can be formed during mounting or mechanical polishing, or because of the growth stresses or thermal stresses.

The oxide layer observed in Figure 2 (d) appears as a single layer. Based on the literatures, the oxide layer on Al-based alloy cladding typically consists of all or some of protective oxide of alumina and oxide-hydrates boehmite and bayerite layer [21], [22]. Boehmite and bayerite formed in the outer surface by degradation of the alumina in the water [21]. The removed oxide layer characterized through XRD [23], also showed two major constituents of boehmite and bayerite. The temperature condition seems to affect the morphology and phase formation of the oxide layer [26]. Semi-quantitative element identification with EDS linescan showed that the layer mainly consists of Al and O atoms (Figure 5).

The thickness of the oxide layer measured using SEM image analysis software was approximately  $10.3 \mu\text{m}$ . The oxide layer formed is very thin and therefore did not change the integrity of the AlMg2 cladding. As a comparison, the thickness of the AlMg2 cladding required for use in the reactor is  $0.25 \text{ mm}$ . In Leenaers' work [23],

Figure 2. Backscatter electron SEM Image of the irradiated fuel plate over the width (cross-section), showing overview of the fuel cross-section (a-c); and more detailed micrograph of the oxide layer on the fuel cladding (d).

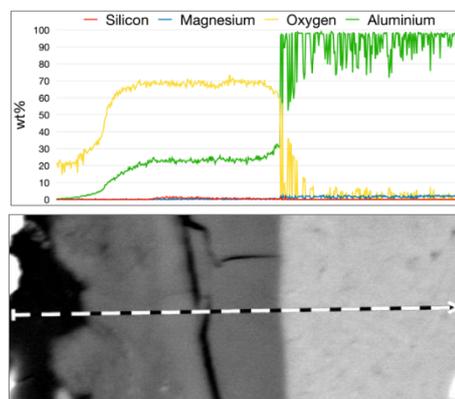
Figure 5. Semi-quantitative linescan covering the AlMg2 cladding and the oxide layer.
