Study of Pedestal Column Foundation of Heater Structures After a Fire Accident

This paper has presented the study of concrete experiencing the fire of the pedestal column of the heater foundation structure after the fire accident. The evaluation was done with the analytical method, which was conducted to find out the actual condition of an existing structure. Structure or components of the structure are categorized as a safe condition; if its design strength is greater or equal to the required strength or $\phi R_n \geq R_u$. Evaluation of the pedestal column structure with the analytical method was done by visual inspection, concrete quality inspection, cracking depth inspection, structural analysis with the finite element software and strength calculation of structure according to the requirement of SNI 2847 2013. The equipment used for concrete quality inspection is Digischmidt Hammer and PUNDIT. The result showed that there was a degradation of the concrete quality of less than 15%. However, with this condition, all of the pedestal column structures are still in a safe condition in receiving the load operation.

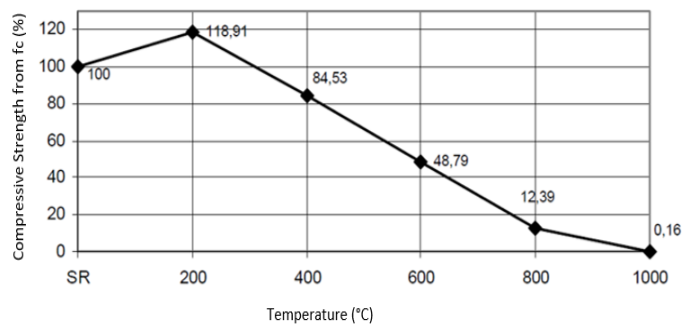
Figure 1. Degradation of concrete compression strength at various temperatures [Suhendro, 2000] [7].

The study of concrete degradation at various temperatures was conducted by several researchers, which are Suhendro (2000) [3], Abrams (1979) and Schneider et al. (1989). The Results of their study are presented in **Table 1** and **Figure 1**, and **Figure 2** [7].

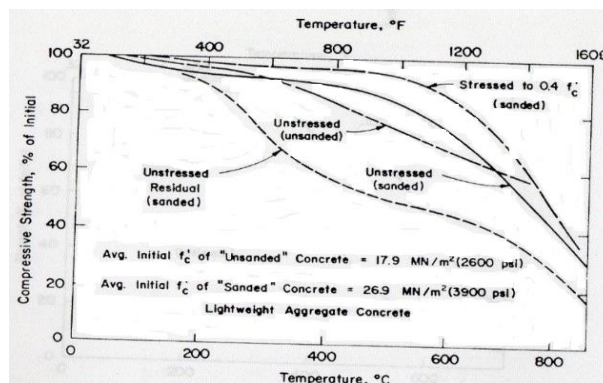
Figure 2. Degradation of concrete compression strength at various temperatures [Abrams, 1979] [7].

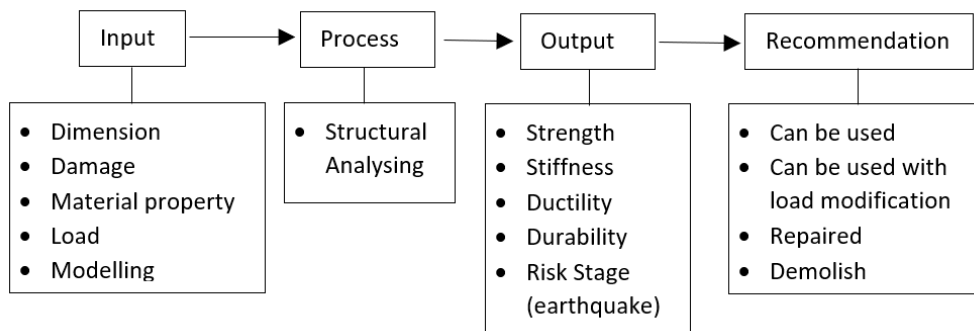
Figure 3. Strength evaluation procedure by analytical method [9].

The general procedure for the strength evaluation of existing structures with the analytical method is presented in **Figure 3** [11].

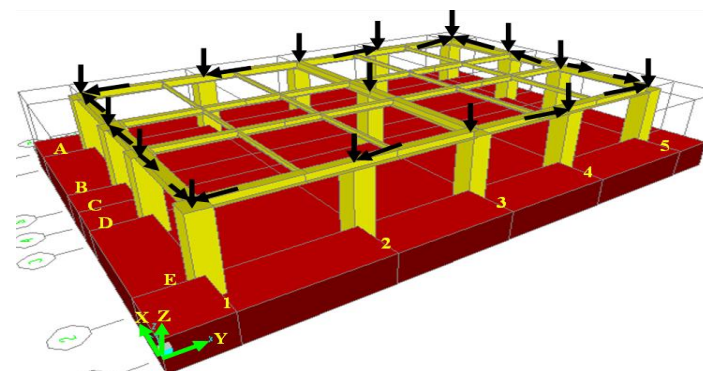
Figure 4. Modelling of pedestal column foundation of heater structure.

Simplification of modelling is needed in the strength evaluation process. Some assumption is applicable in modelling to solve the problem easier but still accommodate or comply with the real condition. In this study, the column pedestal can be modelled as a beam element, as presented in **Figure 4**, with the joint modelled as a continuous joint or fixed joint. The system of structure is modelled in three dimensional, and the support is modelled as a pin joint [12].

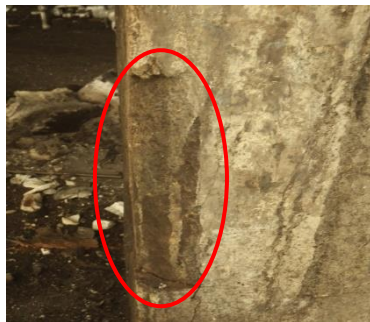
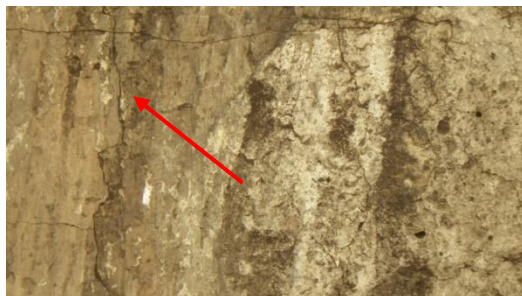
Figure 5. Spalling and crack at column E2.

Crack, spalling and break out are the type of damage that occurred on the pedestal column foundation structure due to a fire accident. A large number of cracks

occur on the pedestal column of E2. Concrete damage on the pedestal column of E2 is presented in **Figure 5**. Results of concrete strength inspection with hammer test and UPV test are presented in **Table 2**.

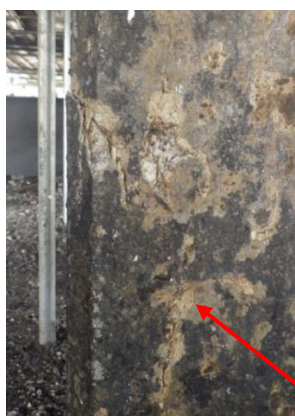
Figure 6. Crack at column A2.

Crack and spalling on concrete may occur after a fire with temperatures up to 200°C because there is compression in the empty pores that causes crack and spalling on concrete. This condition may occur on pedestal columns E1 and A2 (see **Figure 6** and **Figure 7**).

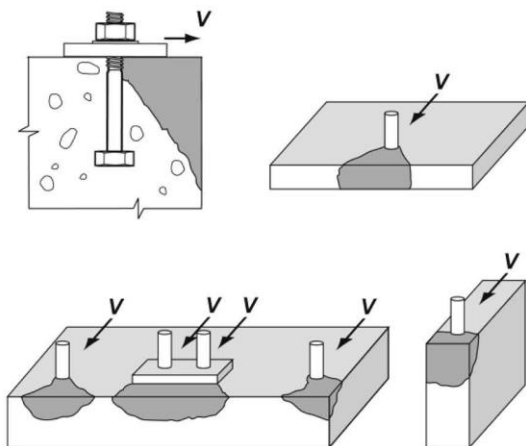
Damage or failure that occurred on pedestal column E1 is a type of broken failure or concrete breakout. This type of failure is caused by a shear load at anchorage support (see **Figure 8**). Based on SNI 2847:2013 standard about the requirement of Structural Concrete for Building mentioned that a structure or component of a structure is in a safe condition if the required strength is below or at least the same as the design strength.

Figure 8. Type of damage in concrete due to shear load at anchorage support.

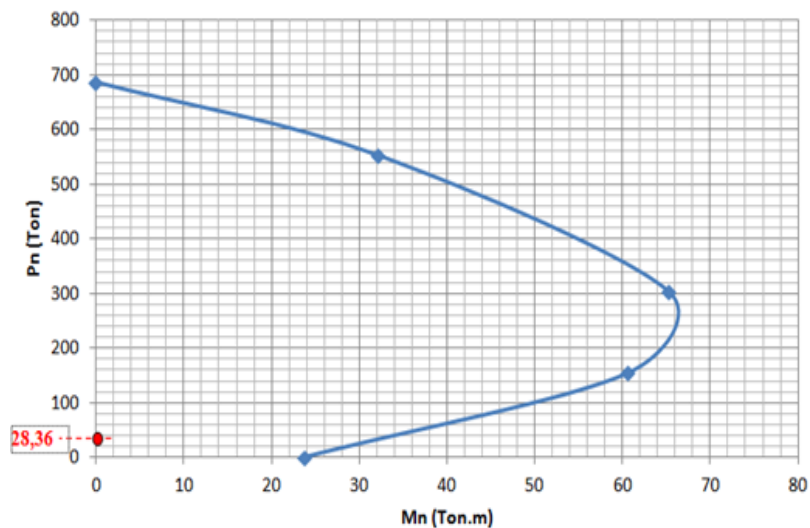
The value of the required strength and design strength of the column is determined by plotting a di interaction diagram between the Nominal load value (P_n) and Nominal Moment value (M_n). If the required strength value is inside of the interaction diagram of design strength, then the column is safe to carry the operational load. But if the required strength value is outside of the design strength interaction diagram, then the column is unsafe for carrying the operational load. Calculation results of the cross-sectional capacity of column (design strength) described the interaction diagram between nominal load (P_n) and nominal moment (M_n) as presented in **Figure 9** for pedestal column foundation C3 and calculation results for other pedestal columns are presented in **Table 9**.

Figure 9. Interaction diagram of P – M at Pedestal Column of C3.

Based on calculation results for the pedestal column of C3, as shown in **Figure 9** and **Table 9** for all of the pedestal columns, it can be seen that all of the pedestal column foundations have the required strength value

inside of the design strength interaction diagram. It means that the pedestal column foundation is safe for carrying the operational load.
