## THE EVALUATION OF THE CAUSES OF RETAINING WALL STRUCTURE FAILURE AT A RIVER BASED ON SNI 2847:2013

Tri Handayani<sup>1</sup>, Sudarmadi<sup>1</sup>

<sup>1</sup>National Laboratory for Structural Strength Technology  
Agency for the Assessment and Application of Technology  
e-mail: tri.handayani@bppt.go.id, sudarmadi@bppt.go.id

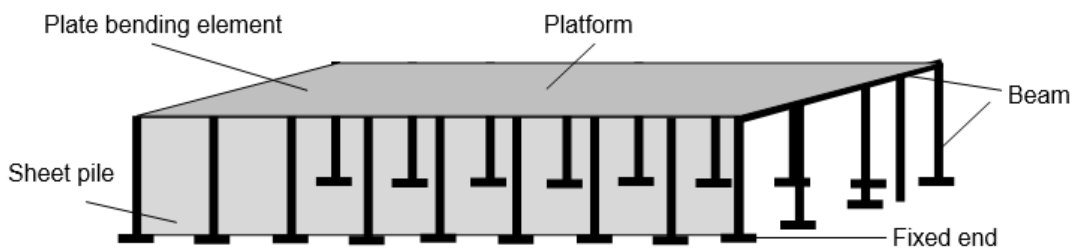
Element Type of Retaining Wall Structure Modelling<sup>10)</sup>

Structural analysis of retaining wall use finite element method software, which is SAP 2000 software. The simplicity of the structural modeling is needed in this study due to a difference between the model and the structure's real condition. In modeling, some assumptions are usually used to solve the problem, but this assumption must be close to the structure's real condition. The retaining wall structure can be modeled as a plate element and beam element, as shown in Figure 2. Joint on this structure is modeled as fixed joint<sup>10)</sup>.

Retaining wall structure can be modeled in 2-dimensional modeling or 3-dimensional modeling. The platform is modeled as a plate bending element. Pile, sheet pile, and beam are modeled as beam elements (frame

element). Support at the bedrock of pile and sheet pile is modeled as a fixed end.

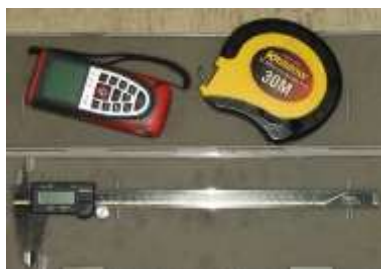
Figure 3.

Dimension Measurement Equipment: (a) Distometer, (b) Roll meter and (c) Caliper

Figure 3 and Figure 4 show the equipment for the pile's dimension and depth measurement. The equipment for dimension measurement consists of a tape meter, caliper, and distometer. Equipment for the pile's depth measurement is Pile Integrity Tester.

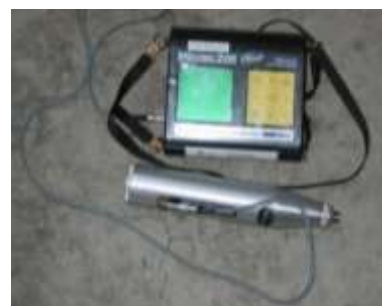
Figure 5.

Digischmidt Hammer Tester

Equipment to check the quality of concrete consists of Digischmidt Hammer, PUNDIT, core drill, and universal testing machine. The set of equipment to check the quality of concrete is presented in Figure 5 to Figure 8.

Quality of concrete measurement by Digischmidt hammer tester are conducted on the platform in 8 locations, pile in 22 locations, and sheet pile in 8 locations. Quality of concrete measurement by ultrasonic pulse velocity method is conducted on the platform in 8 locations, pile in 12 locations, and sheet

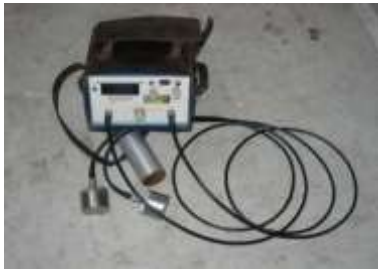
Figure 6.  
Portable PUNDIT

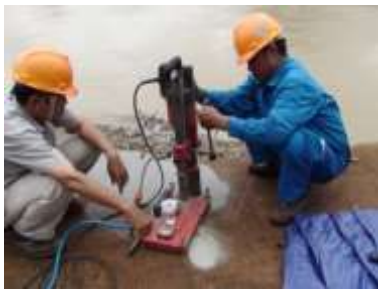
Figure 7.  
Core Drilled Machine

pile in 6 locations. Sampling for core drill is conducted on the platform in 8 locations.

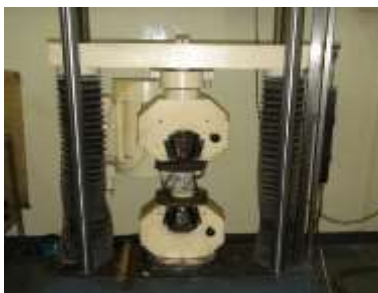
Figure 8.  
Universal Testing Machine

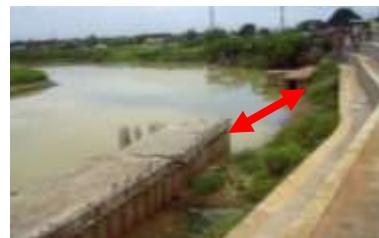
The major damage to the retaining wall structure is the collapse of the structure in the middle section. The water flow at the river base causes the scouring at pile and sheet pile foundation. This scouring made the pile and sheet pile sliding. The pile sliding and vertical load from the structure's self-weight and lateral earth pressure caused an unbalanced condition between the working load and the structure's required strength. Because of this unbalanced condition, the retaining wall structure turned around and collapsed at the middle section. The damage and collapse of the retaining wall structure are presented in Figure 9 and Figure 10.

Figure 9.  
A Collapsed Structure at the Middle Section

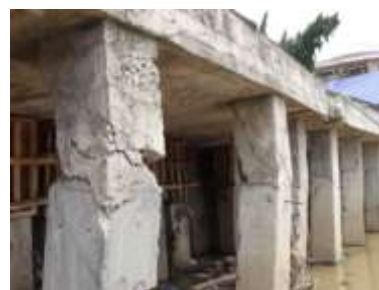
There are many damages to the existing retaining wall structure, including spalling, cracking, and broken at joint pile and column. Crack width is more than 0.4 mm. The damages can cause corrosion in the concrete structure.

Figure 10.  
Broken Pile at Joint

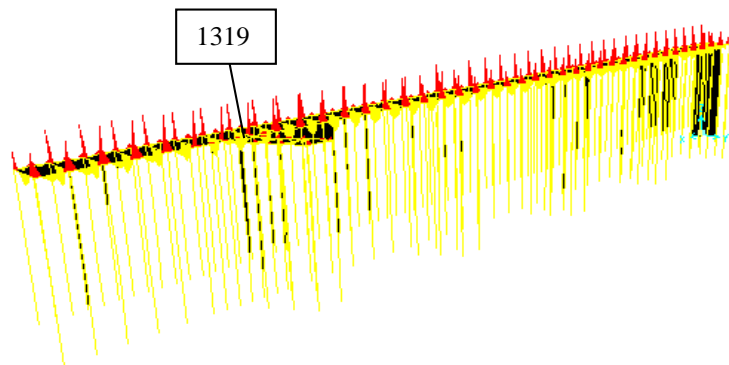
Structural analysis was conducted using software with the finite element method, and the result of the analysis is presented in Table 5 and Figure 11.

Figure 11.  
Structural Analysis Results with Finite Element Method

According to the analysis, the beam component is still in a safe condition, but for pile and sheet pile is not in a safe condition because the received load by structure is bigger than its design capacity.
