## OBSERVATION ON BEACH EROSION AND CORAL DESTRUCTION BY REMOTE SENSING TECHNIQUES

### ABSTRACT

Remote sensing techniques were used to observe beach erosion at Sengkidu Beach, Labuan Amuk, east coast of Bali. Erosion was caused by wave actions flowing over destructed coral reef. Aerial photography was found useful in obtaining first hand information of the destructed corals and its affects on the beach.

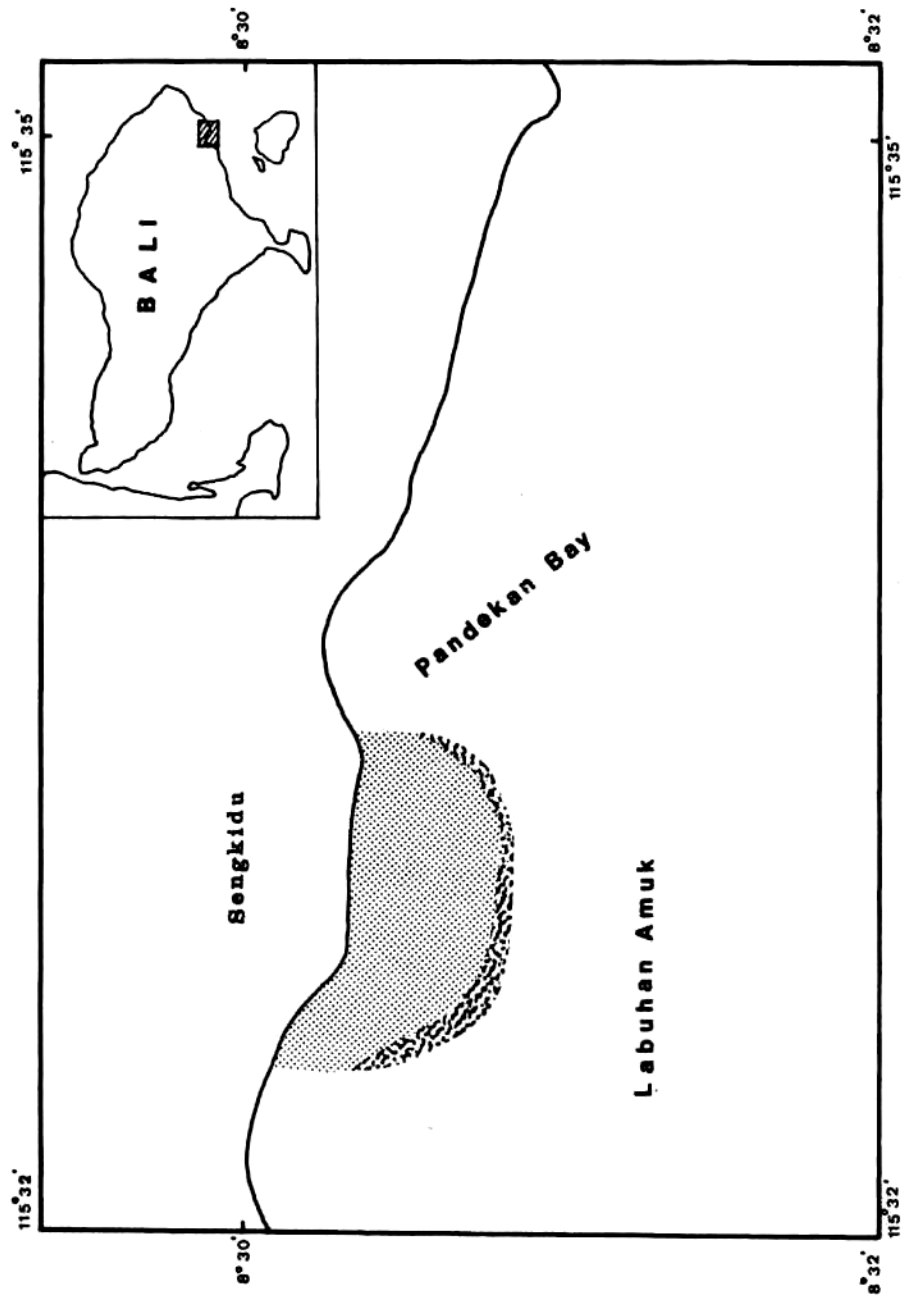
Figure 1. Sengkidu beach, Labuan Amuk, east coast of Bali.

Sengkidu is a small village near the coast on the eastern part of the Bali Island ( $115^{\circ} 33' 30''$  E -  $08^{\circ} 30' 20''$  S). The studied reef flat is stretched in an east-west direction parallel to the shore-line between Labuan Amuk and Pandekan Bay (Fig. 1). The reef flat is approximately 1 km long and forms a barrier at a distance of 150 m off the coast. From the coast, the reef flat is rather horizontal and gradually sloping toward the sea. Water depths varies between 1 to 3 m depending on the tide.

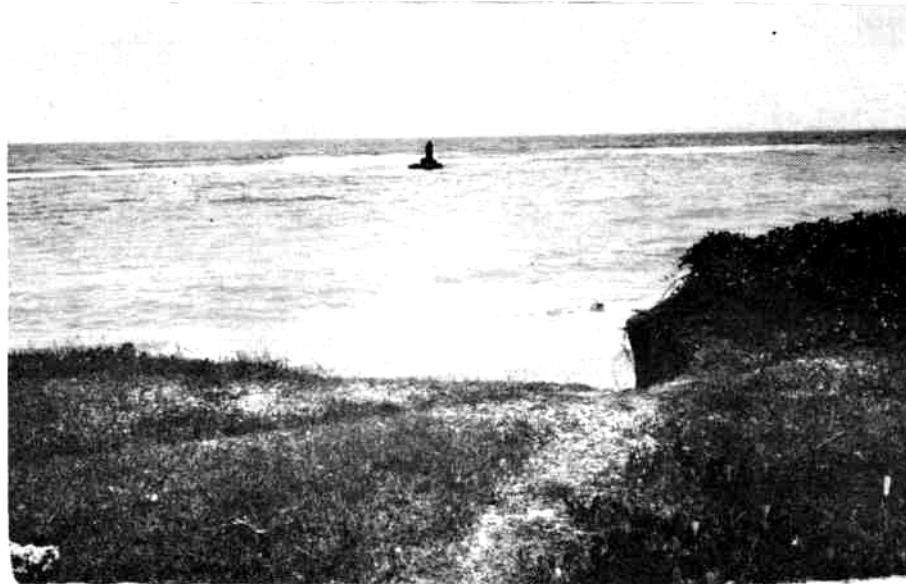
Figure 2. A "puri" (temple) originally built on the coast of Sengkidu is presently seen on a distance of approximately 100 m off the shore.

According to the local inhabitants, some decades ago a "puri" (temple) was built on the coast of Sengkidu. Due to beach erosion the temple is now about 100 m away from the shore (Fig. 2).

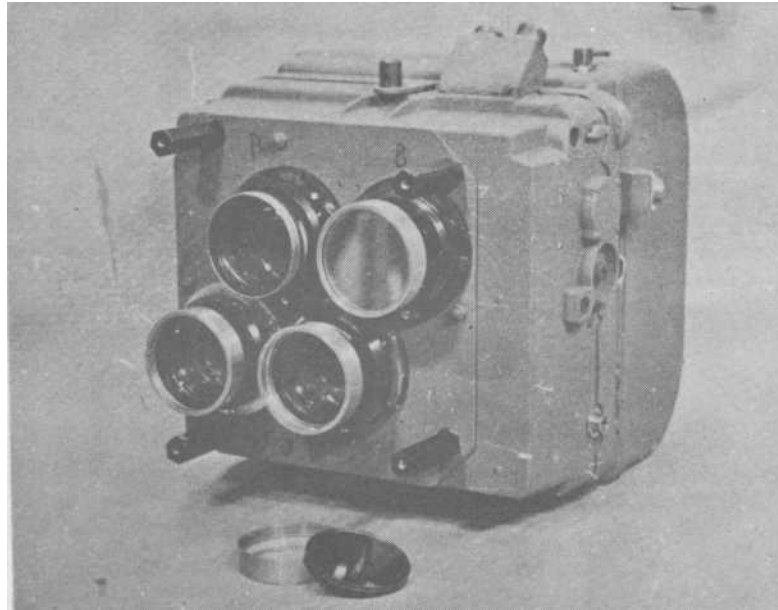
Figure 3. The multispectral camera. A camera with four lenses, each equipped with different filters.

The aerial photographs were taken using a multispectral camera (Fig. 3). The camera consists of four lenses, each equipped with four different filters. Blue, green, red, and infra-red filters were used for our purpose. The film used was a Black & White film which is also sensitive to infra-red spectrum.

Each of the four spectral negatives was taken at the same instant by the four matched lenses. Four spatially identical negatives were produced, since the optical axes of the lenses were normal to the film plane. The obtained images were identical except for the densities which differ partly due to the selective spectral reflectance of ground objects.

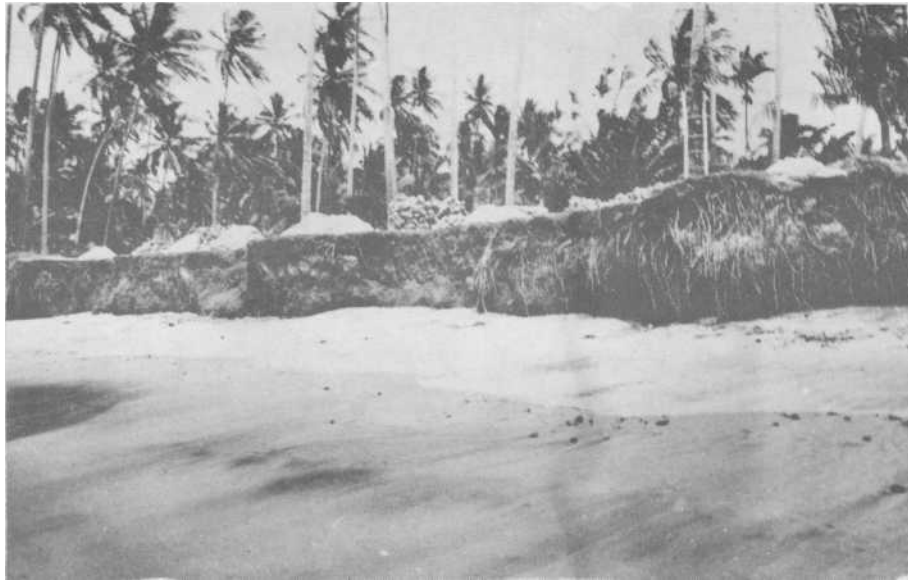
Figure 5. Eroded beach and piles of mined coral.

Images obtained through the infra-red filter shows the best results. Features above sea level can be seen nicely. Reefs are usually studied by observing the breaking of waves on the reef. On some spots, however, this feature does not show up. These may be interpreted as des-tructed coral reef. On those spots the waves are clearly seen passing over destructed coral and acting their force on the beach. Figure 4 shows the area of totally destructed coral, partially destructed, and non-destructed areas. Figure 5 shows the eroded beach and piles of mined coral laying on the beach ready to be transported.

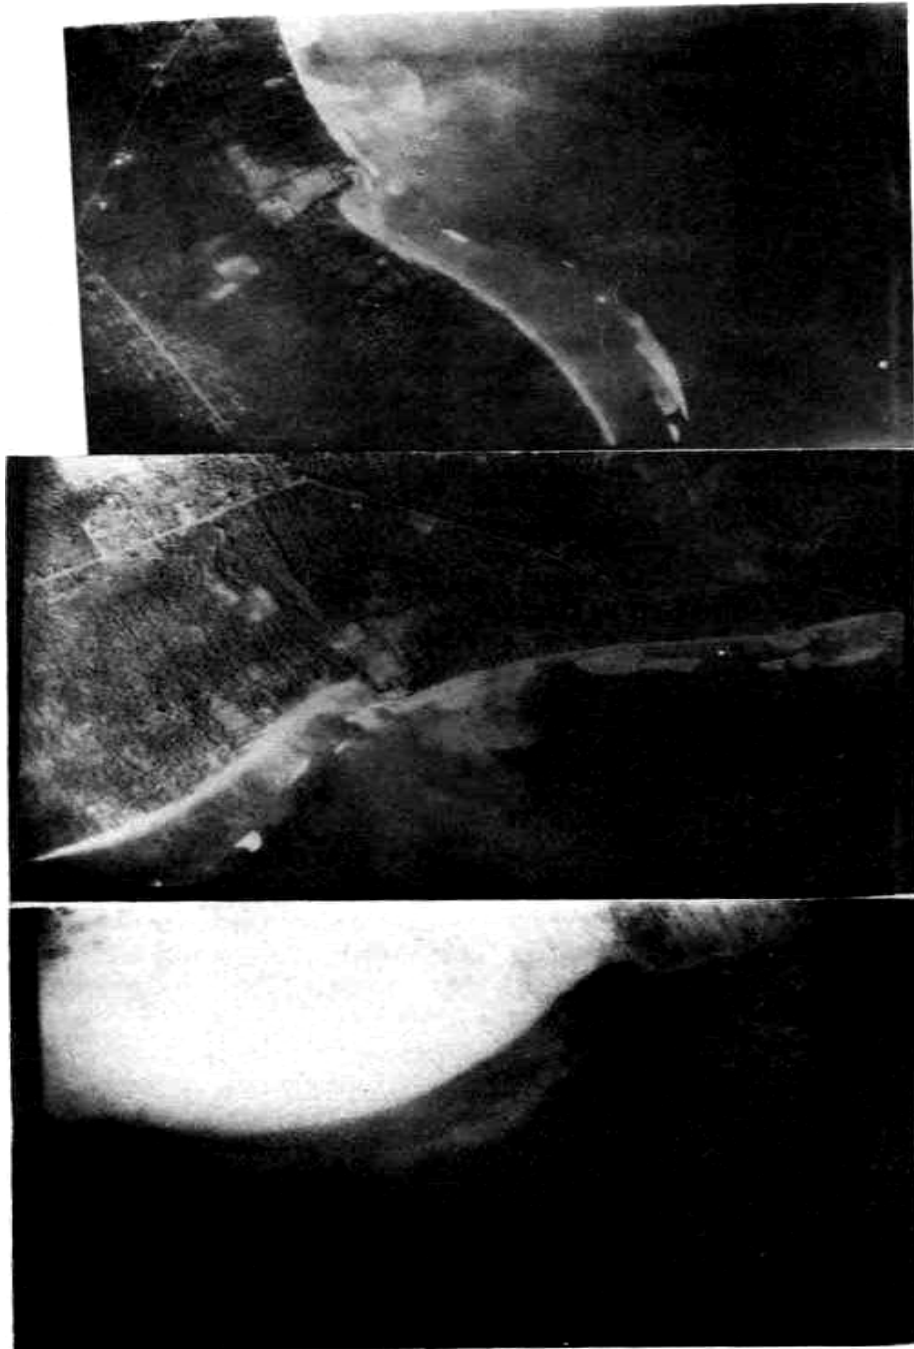
Figure 6. Aerial photographs of Sengkidu Beach taken through three different filters: blue (a), green (b), and infra-red (c). See text for explanation.

Images taken with the blue and green filters shows turbidity patterns of the sea water. The passing waves are not clearly seen due to signals received from the turbidity patterns. Turbidity is likely caused by the eroding effects. Bottom features are not visible on areas of destructed corals. But on non-destructed areas some bottom features are still seen.

To locate reefs, infra-red spectrum is found best suitable, since it will record all features above sea level. The breaker's zone of the reef

can then be located accurately. The red spectrum penetrates the water for a few centimeters which will also indicate coral distribution. However, suspended sediment near the surface will interfere the signals obtained from waves, and waves will show less sharp. The green and blue spectra may be used to study conditions of coral reef. Both spectra are able to penetrate sea water and so catch signals from the bottom of the sea. Both spectra are able to penetrate water to some meters, depending on water transparencies. On areas where beach erosion occurs, plumes of suspensions will interfere the reflections from the bottom, and bottom features will not be clearly seen.
