Gamma Tomography as A Complementary Technique for Pipe Scale Inspection: Field Experiment at Petrochemical Plant

Bayu Azmi[1], Indra Milyardi[1], Megy Stefanus[1], Wibisono[2], Fery Hadi Setiawan[1], Norman Pamungkas[1], and Zulkifli Lubis[3]

[1]Research Center for Radiation Process Technology-National Research and Innovation Agency (BRIN), Jl. Lebak Bulus Raya No 49, Jakarta 12440, Indonesia
[2]Research Center for Radiation Detection and Nuclear Analysis Technology-National Research and Innovation Agency (BRIN), Tangerang Selatan, Indonesia
[3]Chandra Asri Petrochemical Plant, Cilegon 42447, Indonesia
E-mail: bayu.azmi@brin.go.id

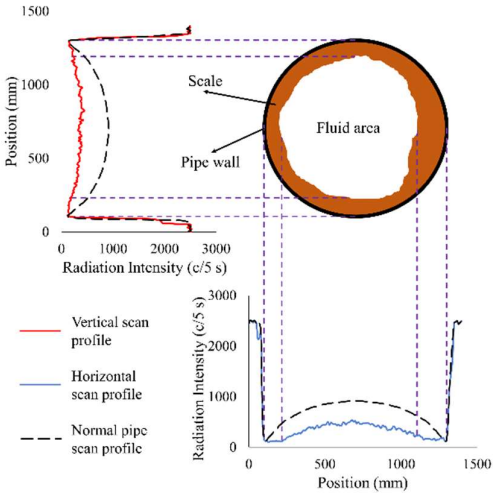
Figure 5. Scale profile prediction at point Q.

The cross-sectional BA-106 scale profiles at 18 points were studied by gamma pipe scanning technique and have been reported by Wibisono et al. [5]. Vertically and horizontally scanning data was plotted to predict the scale profile inside the pipe. Scale profile prediction at point Q (tomography scan point) as shown in Fig. 5. The vertical and horizontal scan profiles at point Q were not symmetrical with the simulated normal pipe scan profiles (black dash lines). The vertical scan profile has indicated that there was a lot of absorption of radiation in the middle and bottom of the pipe when compared to the normal pipe scan profile. Furthermore, the horizontal scan profile indicated most of the absorber location was in quadrants I and IV.

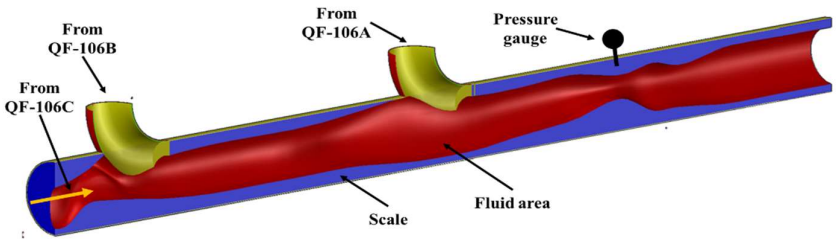
Figure 6. Three-dimenssional scale profile prediction along BA-106 pipeline.

Fig. 6 shows the 3-dimensional scale prediction along the pipeline built from 18 scan positions [5]. The prediction showed there were several deposits of scale at several positions. The first was before the input from QF-106B. It might be caused by the particles contained in QF-106C and the pressure from QF-106B. Then at the pressure gauge, it might be caused by the probe (intrusive) itself that made the particles stick and accumulate to it. The last was at the bottom of the pressure, it might be caused by the particles from input QF-106A. Based on the scale prediction, crack gas from QF-106C and QF-106A were contaminated by particles, while the crack gas from QF-106B was relatively clean. As mentioned before, it came from a 2-dimensional prediction. So, it needs to be confirmed by another technique called tomography.

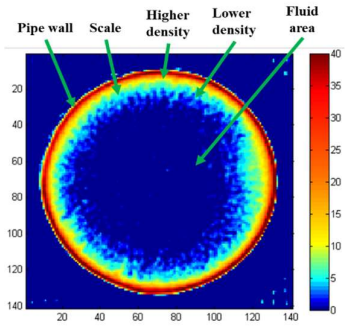
Figure 7. Tomography reconstructed image.

The cross-sectional reconstructed tomography image of the BA-106 pipeline at point Q is shown in Fig 7. The result was able to recognize the pipe wall, scale, and fluid area (gas area). A tomography scan was performed by a parallel scanning method at 10 mm (1 cm) intervals per step. That means each pixel in the reconstructed image represents 1 cm^2 of the actual condition. The color difference in the image shows the difference in the density of the scanned object. The lowest density (air) was represented by the blue color and the highest density (pipe wall) was represented by the red color.

There were some artifacts in the image. This may be due to the relatively small amount of data (projections) in this tomographic inspection. As mentioned before, the number of 32 projections was determined based on consideration of data collecting duration in the field. The artifacts can also be caused by the stability of the scanning system. The mechanical system dimension and conditions in the field made the scanning process not ideal condition. The dimension of the mechanical scanning system made it to be harder to control. Scaffolding stability as the support of a mechanical system is a disturbing factor in the scanning process. Because of the pipeline was under operation during the scanning, its vibration also caused the artifacts in the reconstructed image.

Based on the reconstructed image, the scale density in the pipe varies. Scale that is adhered directly to the pipe wall has higher density represented by the yellow color than the scale further away from the pipe wall represented by the green to light blue color. Scale prediction using vertical and horizontal scan data at point Q was confirmed by the tomographic image. The results were almost identical. While the gamma scan prediction results were subjective, gamma tomography data will produce the same result. It does not depend on the personnel.

Based on the dimensions of objects and conditions in the field, the gamma tomography system was successful in providing the pipe cross-sectional image. The challenge was how to adapt the tomography system to the field conditions. The stability of the mechanical system also needs to be improved to get better data. The duration of scanning was also a limitation of this technique. Therefore, this system needs to be developed into a fan beam method that uses multi-detector. The use of a multi-detector will shorten the scan time. Finally, the gamma tomography technique with image analysis can be used to estimate the remaining fluid area due to the scale in the pipe.

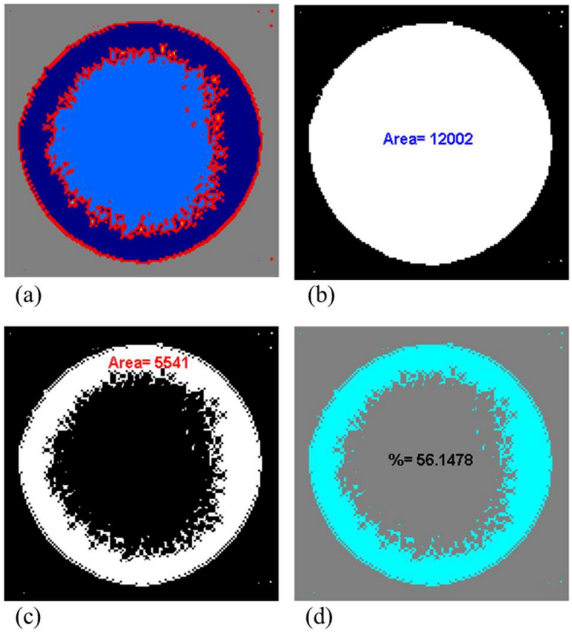
Figure 8. Image analysis. (a) boundary recognition, (b) whole pipe area calculation, (c) pipe wall and scale area calculation, and (d) fluid area percentage calculation.

To complete the inspection, the reconstructed image was analyzed. The purpose of this analysis was to calculate the area of the object in pixel units. In this case, the algorithm traces the exterior boundary of the object (pipe and scale), as well as the boundary of a hole inside these objects (fluid area) as shown in Fig. 8 (a). The red lines are the boundaries of the outer pipe wall and the scale. The dark blue color are the area of the pipe wall and the scale. Whereas the light blue color was the fluid area.

One of the information obtained from the boundary recognition algorithm was the area of the object including its hole as shown in Fig. 8 (b). The white color was the object with 12002 pixels. As mentioned before, 1 pixel in the reconstructed image represents 1 cm^2 of the actual condition, then 12002 pixels equal to 12002 cm^2 (A_c). The actual pipe area is:

Where A_a is the actual area of the pipe. The calculation area (A_c) was 12002 cm^2. There was a discrepancy in the calculation pipe area (12002 cm^2) with the actual pipe area (11669 cm^2). There was a difference of 333 cm^2 from both values. It was 2.85% bigger than its actual area. It could be caused by the quality of the picture was not good enough due to the amount of data and measurement conditions in the field and caused by the pixel dimension being relatively big (low resolution).

Fig. 8 (c) shows the area contained a pipe wall and scale which represented by white color. The calculation area was 5541 cm^2. The fluid area can be calculated by subtracting the whole pipe area from the pipe wall and scale area. It found the fluid area was 6461 cm^2.

The percentage of the fluid area was calculated by comparing the fluid area with the entire pipe area after being compensated with the thickness of the pipe wall as shown in Fig. 8 (d). It was 56.15% of the normal fluid area or 0.5615 × 11187 cm^2= 6282 cm^2.
