FATIGUE AND CORROSION PHENOMENON ON FAILURE OF WATER WALL TUBE BOILER

Eka Febriyanti^a, Amin Suhadi^a, Laili Novita Sari^a

^aBalai Besar Teknologi Kekuatan Struktur (B2TKS), Badan Pengkajian dan Penerapan Teknologi (BPPT), PUSPIPTEK, Serpong, 16314, Indonesia

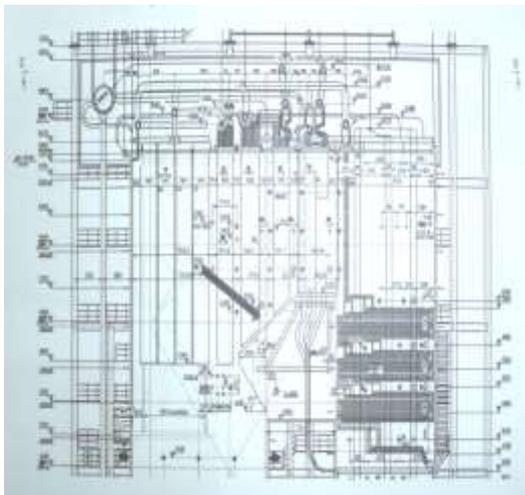
This research observes the failure of steam power plant components called water wall tube boiler which was broken in a position as shown in Figure 1.

Figure 1.
Position of water wall tube in a steam boiler

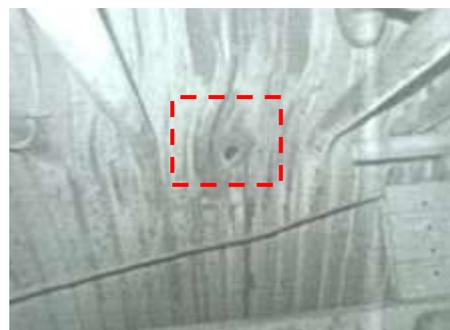
Figure 3.
Position of failure wall tube in boiler (red dot square)

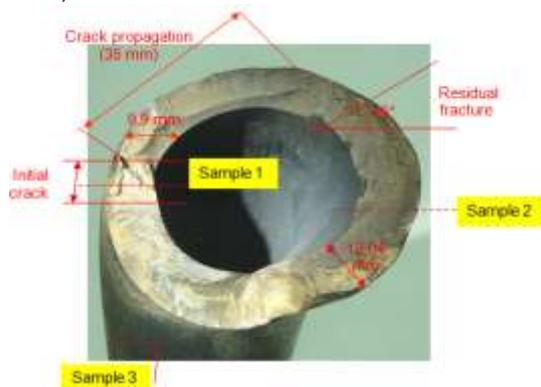
Three specimens are taken from different area on the water wall tube for metallographic examinations as shown on Figure 12. The specimens are then identified as specimen no.1, 2 and 3.

Location taken for metallographic specimens

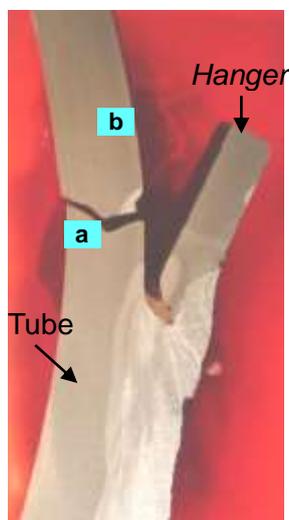
Figure 13.

Metallographic result on specimen number 1. (a) and (b) are location for further exposed

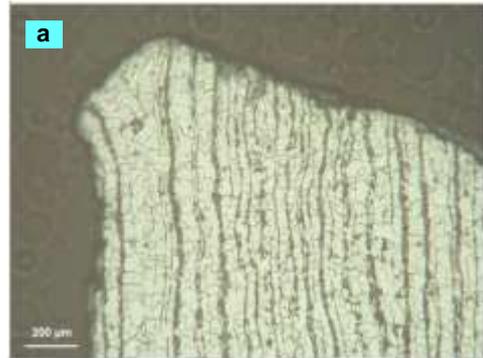
Figure 14.

Microstructure of base metal both on fracture area (location-a) and away from fracture area (location-b) is a mixture of ferrite and pearlite (Figure 14 and 15). This is a normal microstructure of carbon steel material. Metallographic examinations result also shows that trans-granular cracks are exist in both areas. Those cracks produce corrosion agent entering into the structure and then corrosion reaction may occur.

Microstructure of base metal (specimen 1 location-a) consist of a ferrite-pearlite mixture. Etched by: 2%Nital

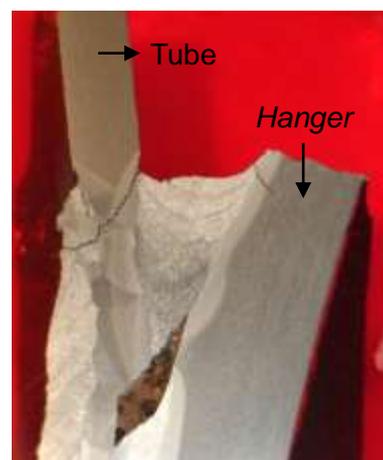
Figure 16.

Specimen number 2 is taken on weld area between tube and hanger (Figure 16). Microstructure of this area is bainite and a macro crack is observed, propagated from weld area to base metal (Figure 17).

Specimen number 2 for metallographic examination

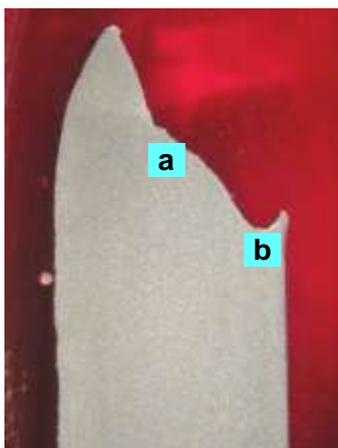
Specimen number 3 is taken away from surface fracture (Figure 18). Microstructure of this area is a mixture of ferrite and pearlite (Figures 19-20). Metallographic examination on this area also found micro crack on base metal (Figure 20).

Figure 18.
Specimen number 3 for metallography examination

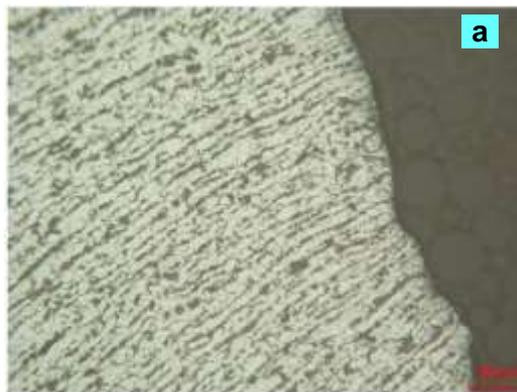
Figure 19.
Microstructure of base consist of a mixture of ferrite and pearlite. Etched by 2%Nital

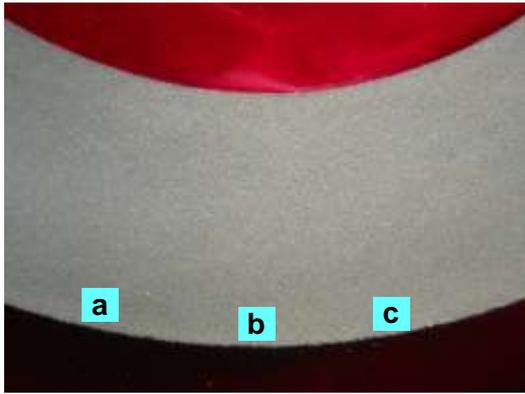
Specimen number 4 is taken from cross section of un-installed water wall tube which is still on good condition (Figure 21). Microstructure of this specimen is a mixture of ferrite and pearlite like microstructure of other specimens. However, this specimen shows a small manufacturing defect in the structure (Figure 22-23). The defects are formed like a small hole and the microstructure grain boundary is following this contour⁵⁾. This small hole is also filled with corrosion products (Figure 22-23).

Figure 21.
Specimen no 4 for metallographic examinations

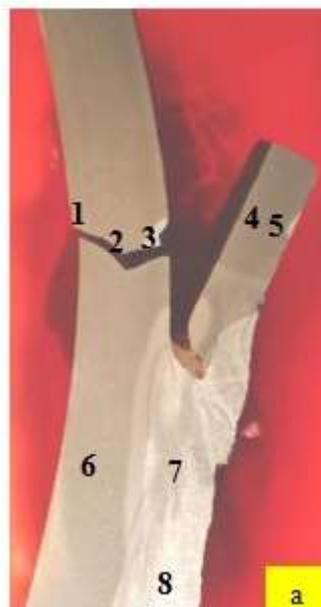
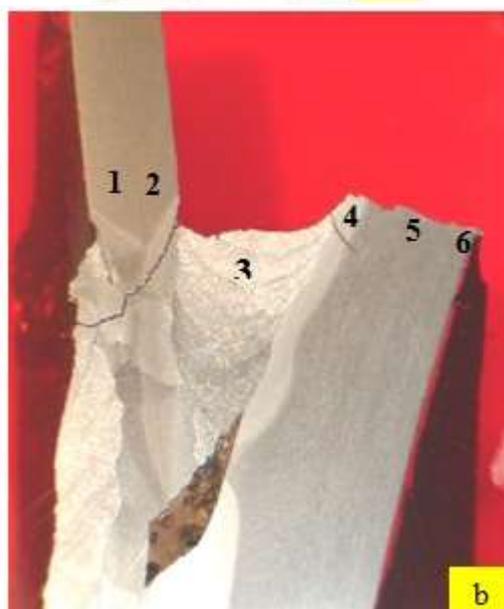
Figure 25.
Specimen for hardness test of failure tube around failure area

No.	Hardness Vickers (HV)	
	a	b
1	210	156
2	208	165
3	271	254.5
4	167.5	243.5
5	162.5	188
6	201.5	192
7	202	
8	220.5

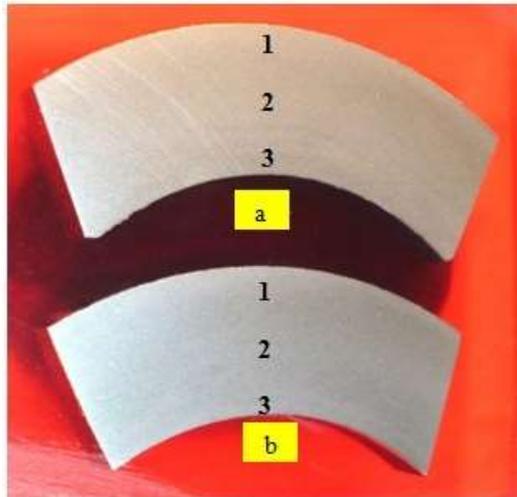
Figure 26. Hardness test specimen on cross section of failure tube and un-installed tube away from failure area

No.	Hardness Vickers (HV) of tube	
	Un-installed	Failure
1	165	170.5
2	156	161
3	153	156
Average	158	162.5
