FAILURE ANALYSIS ON SLINGER DISK PIPE OF PURIFIED TEREPHTALIC ACID (PTA) VESSEL

Sukandar¹, Triwibowo¹, Yana Heryana¹

¹National Laboratory for Structural Strength Technology
Agency for the Assessment and Application of Technology
e-mail: sukandar@bppt.go.id

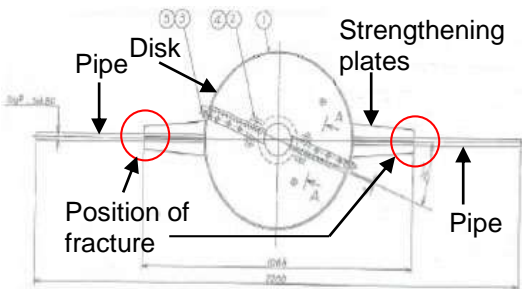
Figure 2. The Slinger Disk Pipe Structure

Failure took place on the both pipes of the slinger disk pipe at the strengthening

plates tip. For this failure analysis, it is taken one failure pipe as sample (Figure 2 and 3).
