## OXIDE LAYER CHARACTERIZATION OF AlMg<sub>2</sub> CLADDING OF IRRADIATED U<sub>3</sub>Si<sub>2</sub>/Al FUEL WITH 4.8 gU/cm<sup>3</sup> DENSITY

Juan Carlos Sihotang<sup>1</sup>, Maman Kartaman Ajiriyanto<sup>1</sup>,  
Ely Nurlaily<sup>2</sup>, Junaedi<sup>2</sup>, Aslina Br. Ginting<sup>1</sup>

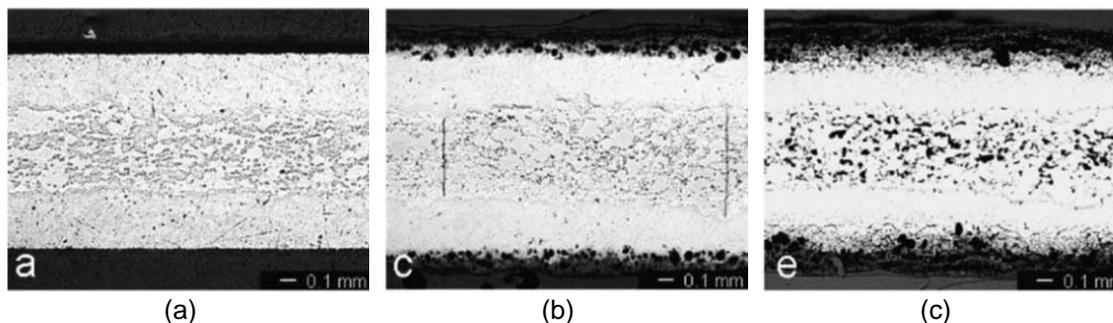
Figure 3. Image of the cross-section of the fuel plate submitted to  $\sim 450 \text{ W/cm}^2$  (a);  $\sim 500 \text{ W/cm}^2$  (b); and  $\sim 550 \text{ W/cm}^2$  (c) from Leenaers' work [22], showing granular aspect of pitting corrosion on the Al5754 alloy cladding.

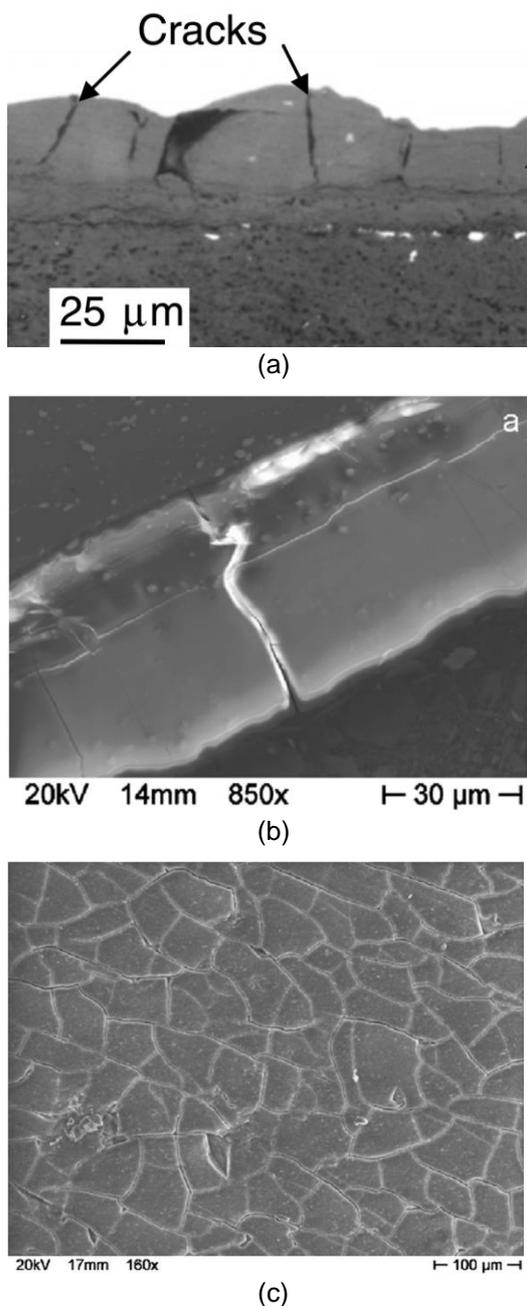
Figure 4. Micrograph showing cracks in the oxide layer of fuel cladding: AG3NE cladding in SIMONE LC-04 fuel test [21] (a), and; AlFeNi cladding from U<sub>3</sub>Si<sub>2</sub> fuel [23] cross section (b) and surface (c).
